# Shorewood Forest Subdivision Storm Water Infrastructure Study

January 2023

Porter County Department of Development  
& Storm Water Management

Christopher B. Burke Engineering

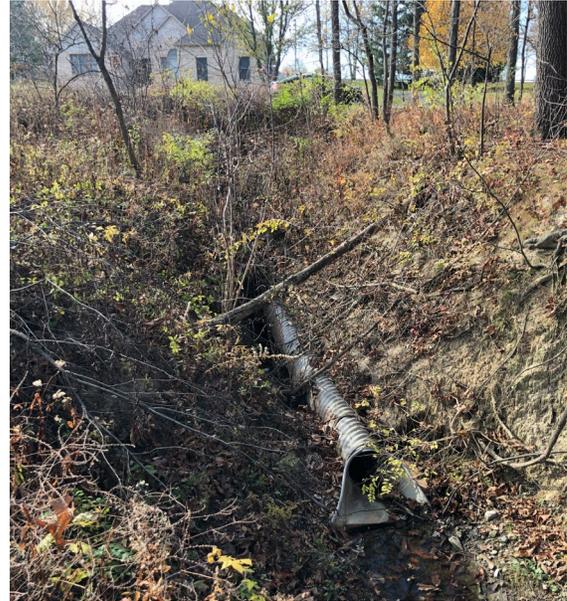
**Figure 4. Pipe Failure/Erosion**

The focus of the field reconnaissance was on those known problem areas and the stormwater infrastructure located outside of the public right-of-way. The observed pipe problem areas are depicted on the *Drainage Exhibit (Exhibit 5)*. These problem areas are a combination of those reported by the residents and those documented during the field reconnaissance performed by CBBEL and Department staff. The majority of these cases involved CMP culverts or storm sewer outfalls at ravines where the pipe bottom has rusted out, and material below and around the pipe has eroded away.

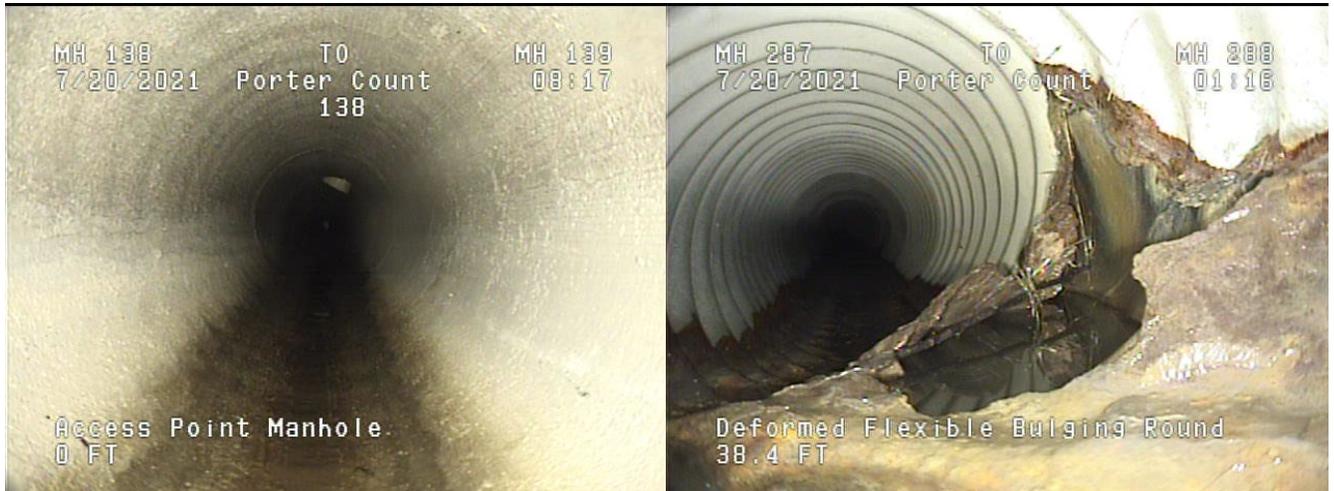
**Figure 5. Sewer Televising Footage: RCP in Good Condition (Left), CMP with Missing Bottom (Right)**

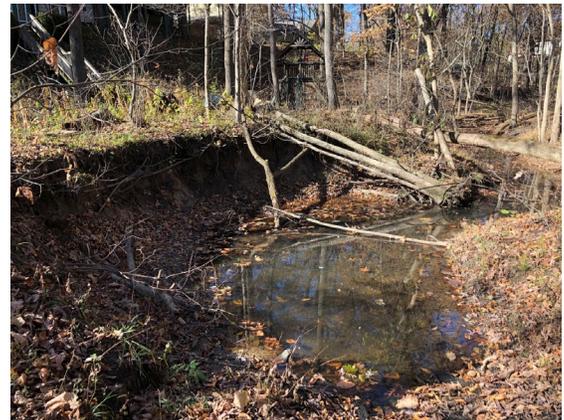
Over the years, those ravines have experienced erosion, head-cutting, and slope instability which has led to increased sediment loading in the lake. Due to the highly erodible nature of the soils in this area, the ravines have experienced varying degrees of erosion from a number of sources, including: excessive flow velocities/flowrates resulting from large upstream drainage areas, deteriorated culverts and storm sewer outfalls, directly connected downspouts, and failure of previously installed stabilization measures. A total of 10 stormwater concern reports involving ravine erosion problems were submitted by residents. Throughout the course of the study, several other residents voiced their concerns over increased sediment loading in Lake Louise that they believe was directly related to the ravine erosion problem.

**Figure 6. Bank Erosion with Tree Undermining**

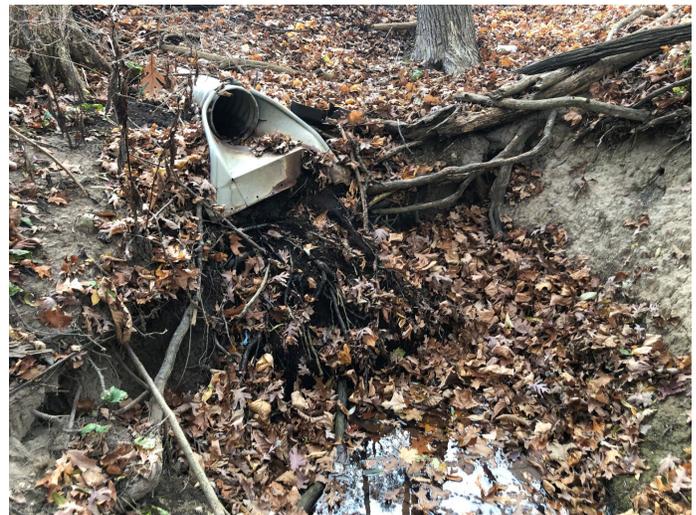
As part of this field assessment, concentrated discharges from the storm sewer system and private property were observed to be a significant source of erosion along the ravines. As discussed under the *Storm Sewer/Culvert Assessment* section, severe erosion was observed at several deteriorated CMP culverts. The displacement of material under and around the pipe will continue with each rainfall event. Additionally, severe erosion was observed at nearly every storm sewer outfall into the ravine which has resulted in a significant vertical drop between the pipe invert and the channel bottom. An example of this is provided in **Figure 7**.

**Figure 7. Severe Erosion at Storm Sewer Outfall**

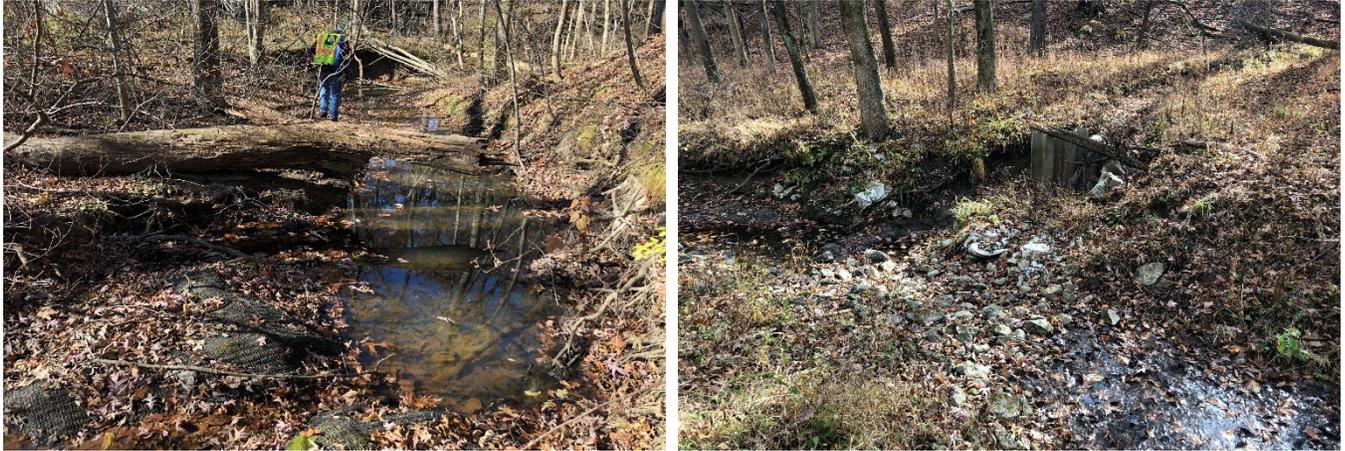
measures appear to be situated in appropriate locations, but have mostly become clogged with debris, show signs of failure, and are no longer providing their original function.

**Figure 8. Failed TRM/Riprap Check Dam (Left) and Failed Sandbag Check Dam (Right)**

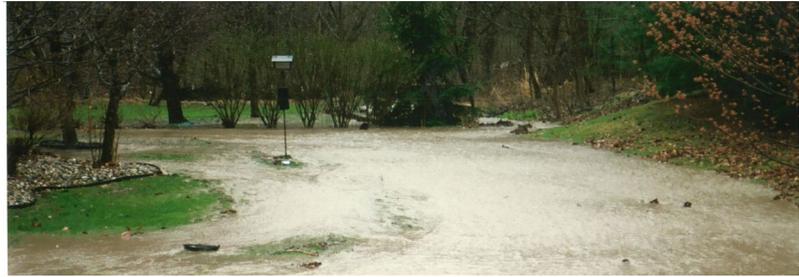
Problem Area 1 involves the three residences located at 194-198 Wexford Road and involves severe backyard flooding that causes structural flooding for one residence during extreme events. There is a total of 14 acres that drains through an existing ravine that originates on the east side of CR 500 W. The ravine drains to a single inlet located at the southwest corner of the 196 Wexford Property. The inlet is outfitted with a high-capacity stool-type grate that connects an existing 24-inch diameter CMP to the storm sewer along Wexford Road.

**Figure 10. Rear Yard Flooding - 194-198 Wexford Road**

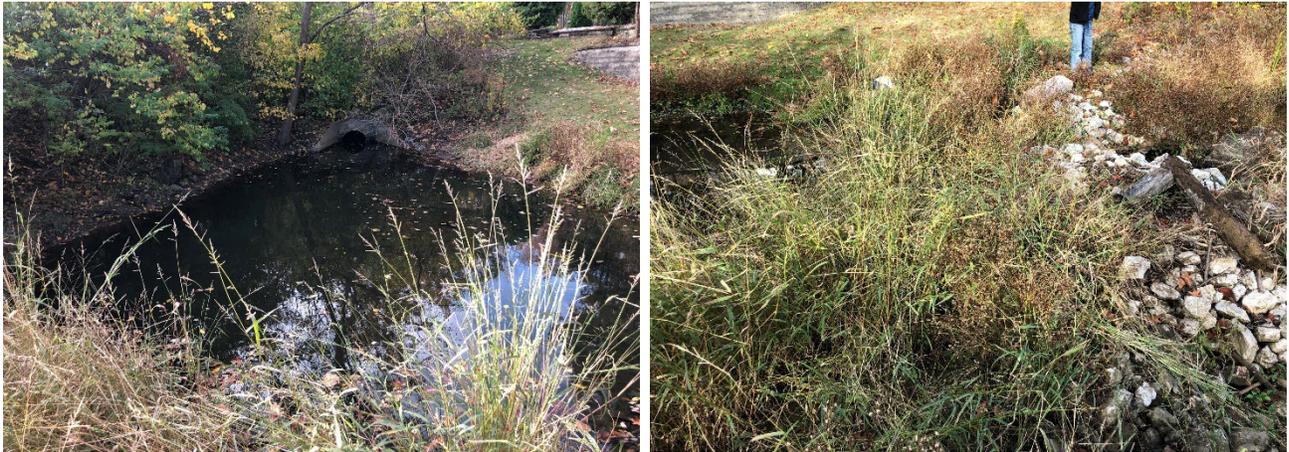
The existing forebay is approximately 20-ft wide by 50-ft (measured in the direction of flow) and was created by constructing a riprap dam across the bay in this location. Based on our field reconnaissance, portions of the riprap dam are failing and the effectiveness of the forebay has been significantly diminished. Several residents have reported large amounts of sediment-laden runoff, as well as the accumulation of debris, in this location during storm events.

**Figure 4. Existing Sediment Forebay Looking Upstream (Left) Deteriorated Riprap Dam (Right)**

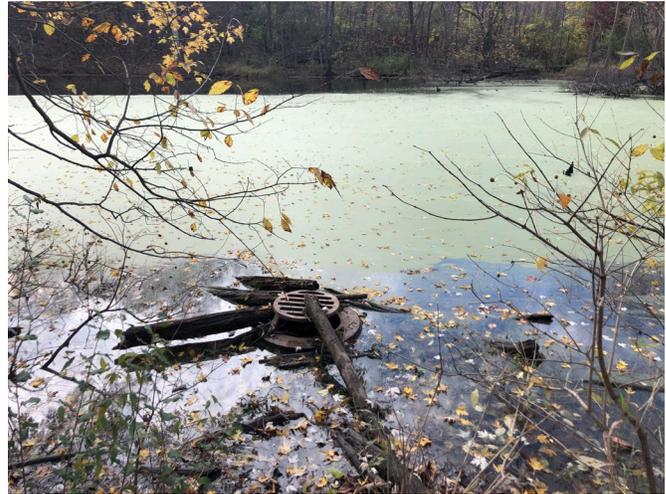
The normal water level (NWL) of the wetlands is controlled by two overflow grates that convey water to the Devon Ravine through 18- to 24-inch storm sewers under the Nature Walk. There is an existing berm located along the south side of the trail, which is set approximately 0.5 feet above the NWL of the wetland.

**Figure 13. Existing Outlet – Nature Walk Wetland**

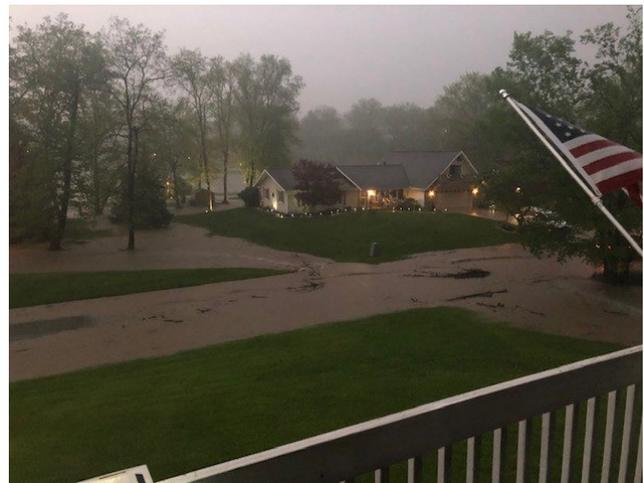
The culverts in this location consist of two CMP arch pipes with dimensions of approximately 36 inches (rise) by 54 inches (span). The poor condition of the pipes, in addition to sediment accumulation in this location, further diminish the conveyance capacity of the culverts.

**Figure 15. Existing Flooding Along Roxbury Road**

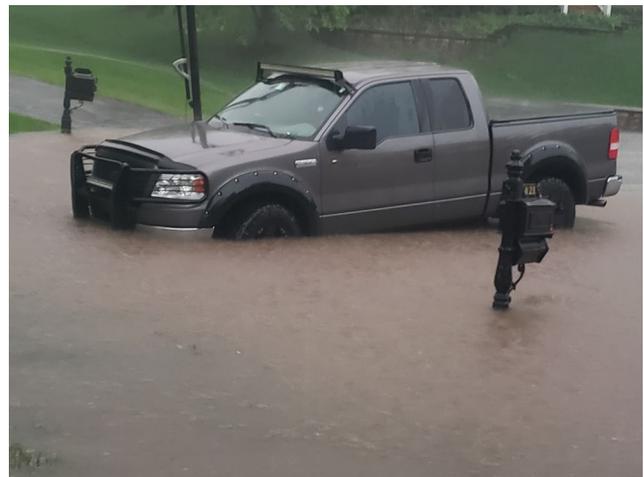
Brookshire Court residents have reported flood depths of up to two feet during recent storm events. There are additional concerns regarding existing electrical equipment located within the ponding area. The existing conditions XP-SWMM modeling indicates an existing 100-year flood depth of approximately 2.5 ft, measured above the rim elevation of the inlet. A depiction of the 100-year inundation area for this location is shown on **Exhibit 6**.

**Figure 16. Existing Flooding Along Brookshire Court**

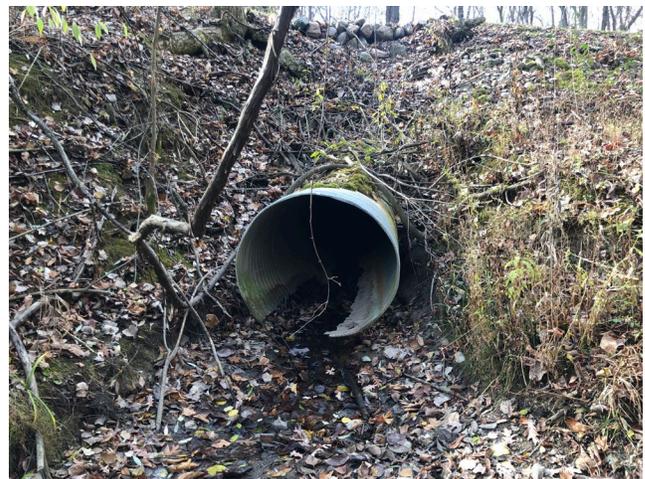
Based on field reconnaissance performed by CBBEL staff, it was observed that the bottom of the pipe has corroded through, with significant material loss below and around pipe. Severe pipe deformation, joint separation, and settling of pipe sections was also noted. This section of pipe could not be televised due to the missing bottom sections.

**Figure 17. Existing Driveway Culvert – 157 York Circle**

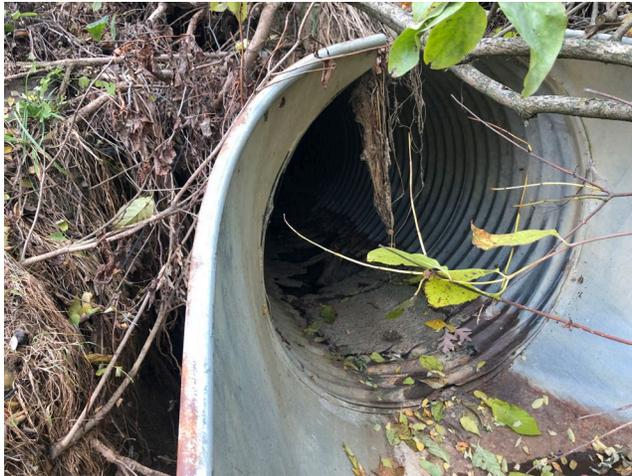
**Figure 7. Existing 42-Inch CMP Outlet**

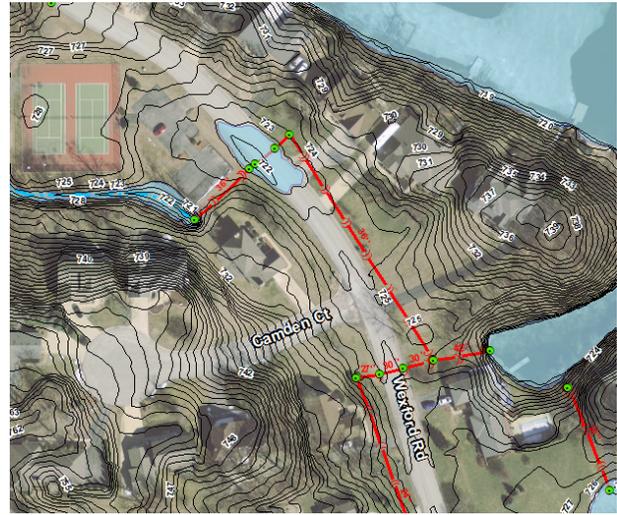
The total drainage area to this location is approximately 20 acres, 16 of which drains through the existing ditch/culvert located south of the tennis courts. The XP-SWMM existing conditions analysis indicates approximately two feet of flood depth in this location during the 100-year critical duration storm event.

**Figure 19. 100-Year Inundation Area – Problem Area 12**

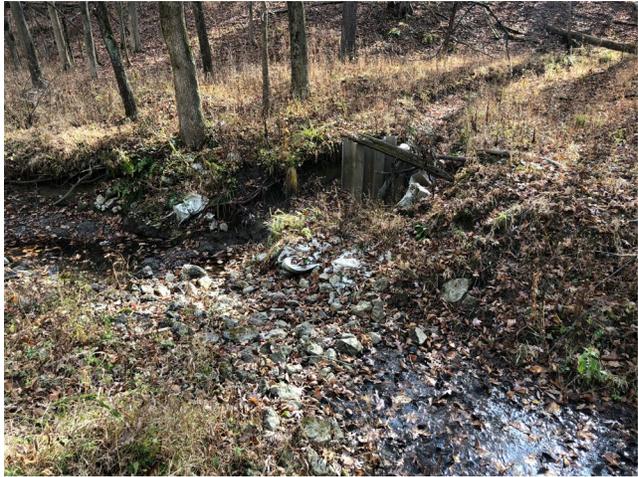
These check dams exhibit some signs of failure, particularly in the form of flanking (flow passing around the structure rather than over it). Erosion has occurred around the outer edges of these structures, which reduced their effectiveness. Portions of the riprap have toppled and provide limited impoundment capacity. Additionally, a significant amount of debris and sediment have accumulated on the upstream sides of these structures

**Figure 20. Existing Riprap Check Dam**

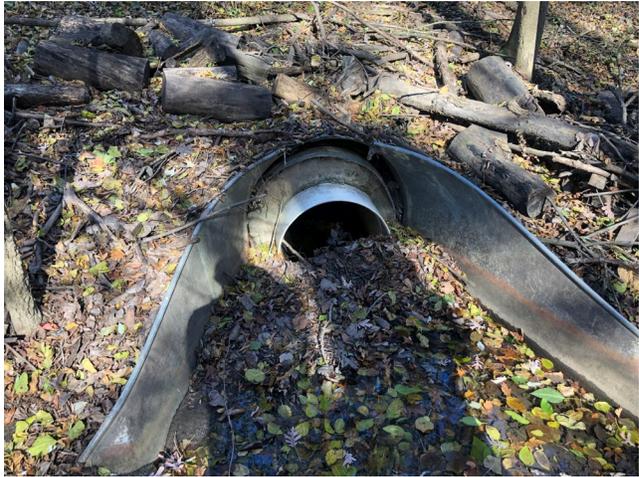
As shown in **Figure 21**, the PVC pipe was grouted inside of two previous CMP culverts with diameters of 42- and 48-inches, respectively. While this modification was likely performed from purely a maintenance standpoint, the reduction in pipe capacity allowed more utilization of the flood storage on the upstream side of Devon Road.

**Figure 21. Existing Devon Road Culvert**

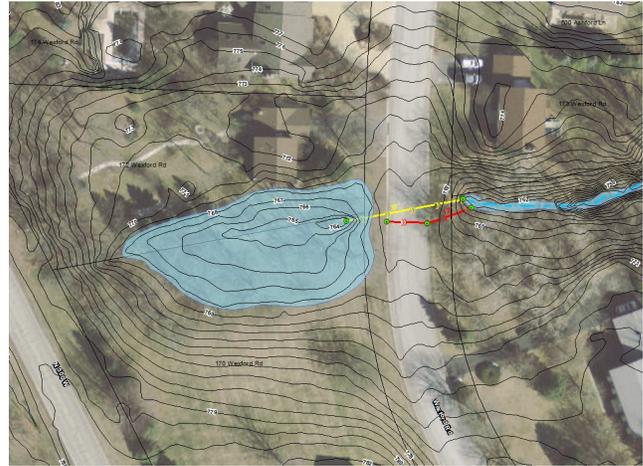
Problem Area 16 is located at the headwaters of the Ashford Ravine and involves significant side/rear yard flooding for two homes (170 and 172 Wexford Road). As shown in **Figure 22**, an approximately 13-acre area drains to an existing 15-inch diameter HPDE culvert located under Wexford Road. An additional 1.5 acres of roadway drainage is collected in the 12-inch diameter CMP storm sewer in this location, which discharges to the east side of the road as a separate outlet. Although the 15-inch diameter HDPE culvert was determined to be in good condition, the 12-inch storm sewer was assessed to be in poor condition.

**Figure 22. 100-Year Inundation Area – Problem Area 16**

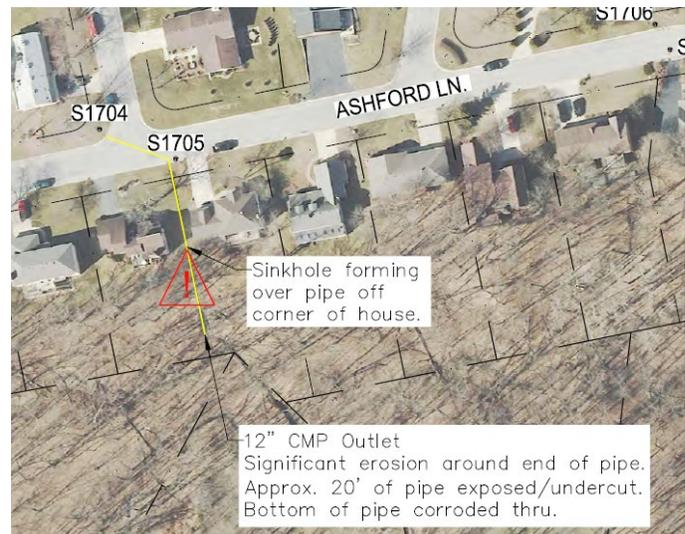
The storm sewer televising confirmed the poor condition of this storm sewer segment, with several large holes shown in the footage. The upstream storm sewer segment along Ashford Lane could not be televised due to the presence of heavy debris.

**Figure 23. Pipe Failure at 492-494 Ashford Lane**

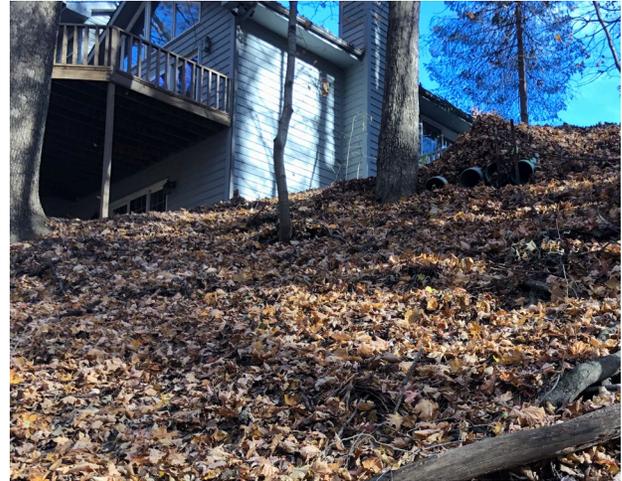
**Figure 24. Downspouts Discharging at Top of Bank**

- 1) Disconnection of building downspouts: A significant source of erosion is the discharge of rainwater into the ravines via downspouts and slope drains. Once rainwater discharges from the downspouts, the water travels along defined paths and rills are created. As the water travels downslope, the rills deepen and widen into large gullies. In cases where downspouts are connected to slope drains, the drains usually discharge directly into ravines, where the velocity and volume of this water causes erosion in the ravines. What may begin as a small discharge from a downspout quickly becomes a problem as the slope steepens and the highly erodible soil washes into the ravine. These downspouts should be disconnected and allow to discharge at-grade to promote infiltration prior to reaching the ravine.

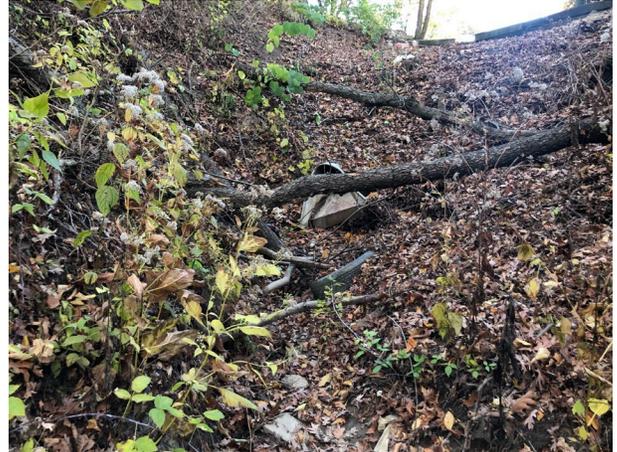
**Figure 25. Erosion at Storm Sewer Outfall**

The reconstruction or rehabilitation of each storm sewer outfall, along with implementing appropriate energy dissipation measures, will significantly improve the on-going erosion issues.
