Greater South Haven Drainage Study-
Coventry, New South Haven and Salt Creek Valley Commons
Porter County, Indiana

APPENDIX III B- Select Video Inspection Photographs

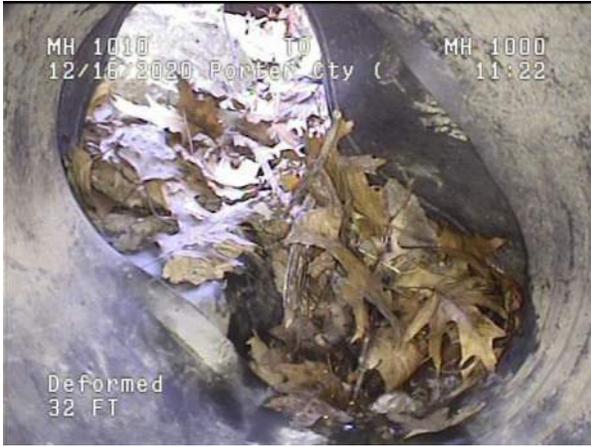
Picture 1 - Pipe 1010-1000: Deformed

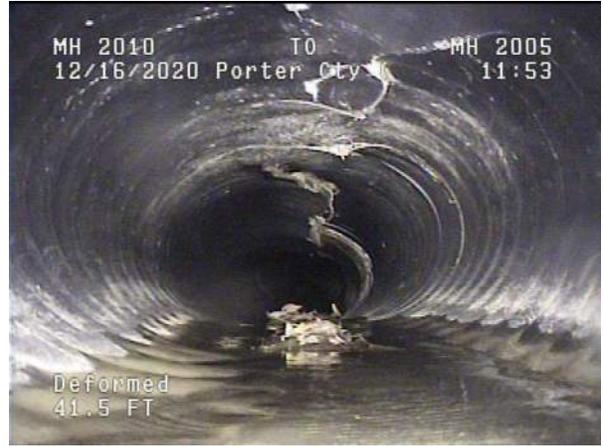
Picture 2 - Pipe 2010-2005: Broken and Deformed

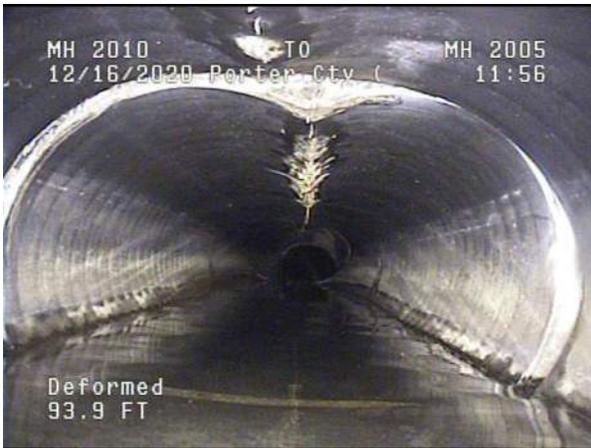
Picture 3 - Pipe 2010-2005: Top Fractured

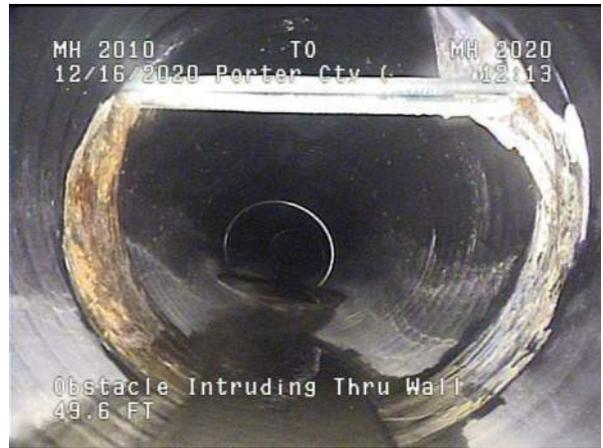
Picture 4 - Pipe 2010-2020: Utility Perforation

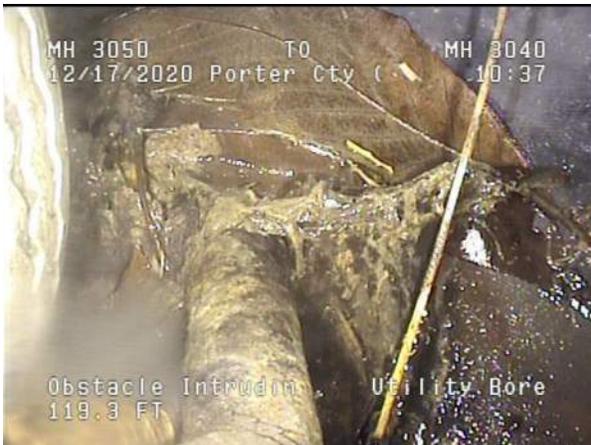
Picture 5 - Pipe 3050-3040: Utility Perforation

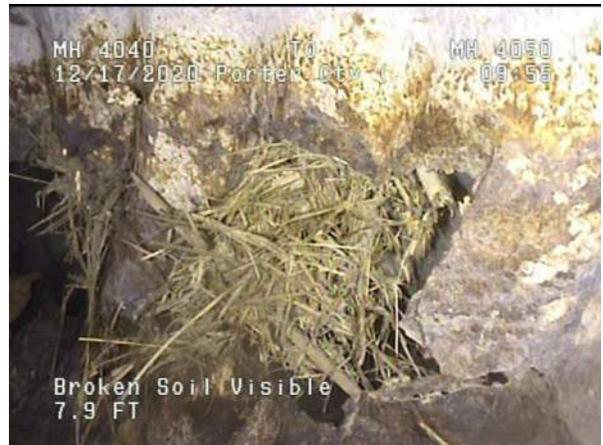
Picture 6 - Pipe 4040-4050: Bottom Corroded Away

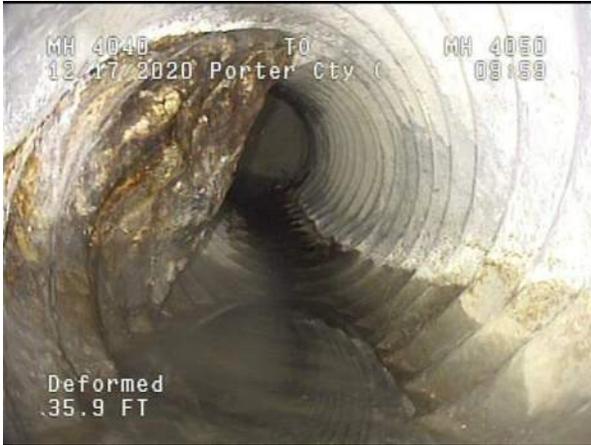
Picture 7 - Pipe 4040-4050: Deformed

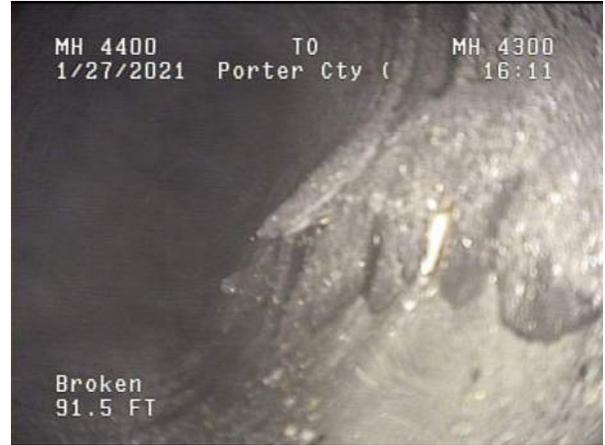
Picture 8 - Pipe 4400-4300: Broken Bottom

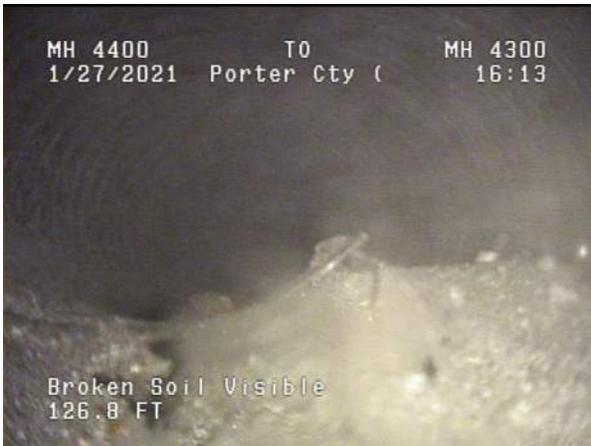
Picture 9 - Pipe 4400-4300: Broken Bottom

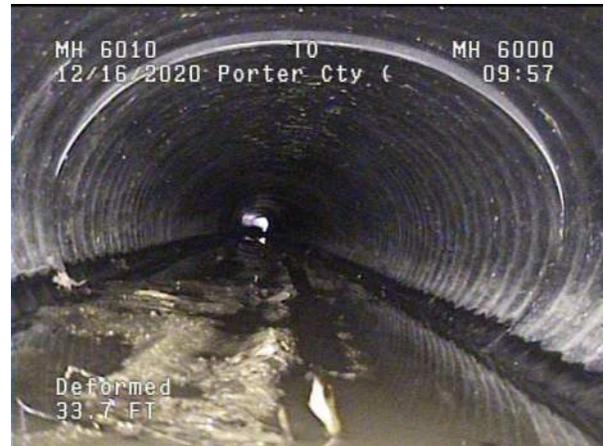
Picture 10 - Pipe 6010-6000: Deformed

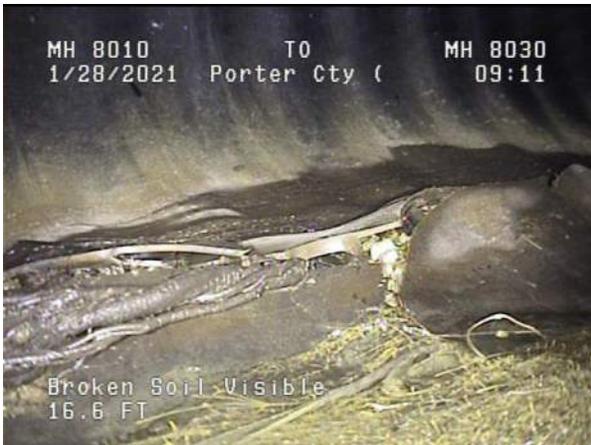
Picture 11 - Pipe 8010-8030: Deformed

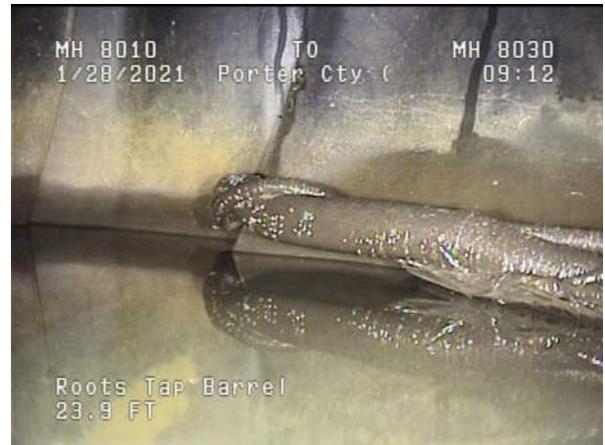
Picture 12 - Pipe 8010-8030: Tap Root

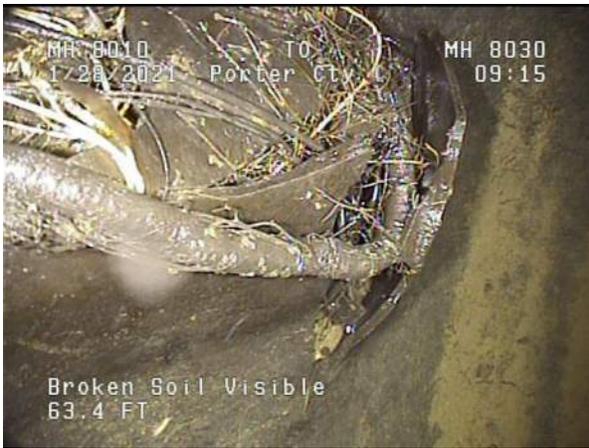
Picture 13 - Pipe 8010-8030: Broken with Roots

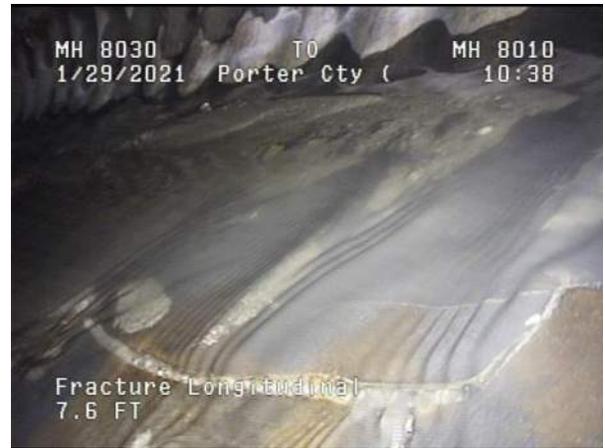
Picture 14 - Pipe 8030-8010: Broken Bottom

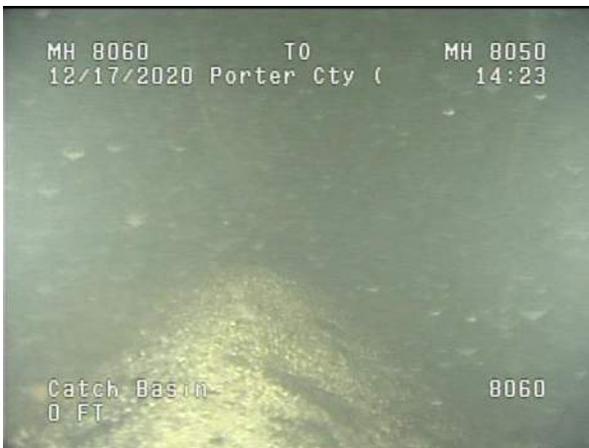
Picture 15 - Pipe 8060-8050: Standing Water / Low Area

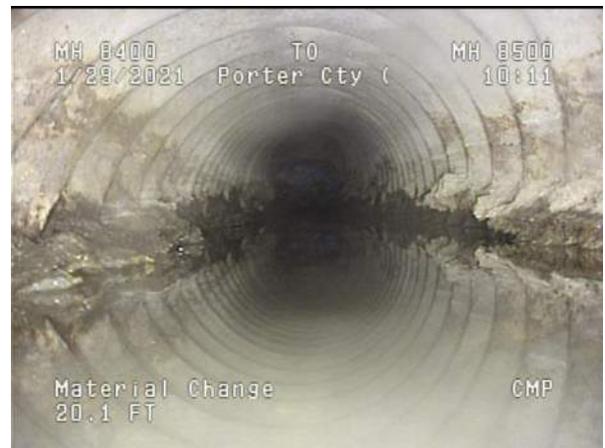
Picture 16 - Pipe 8400-8500: Corrosion, Poor Slope, Deposits
