Greater South Haven Drainage Study-  
Coventry, New South Haven and Salt Creek Valley Commons  
Porter County, Indiana

## APPENDIX IV B - Select Video Inspection Photographs

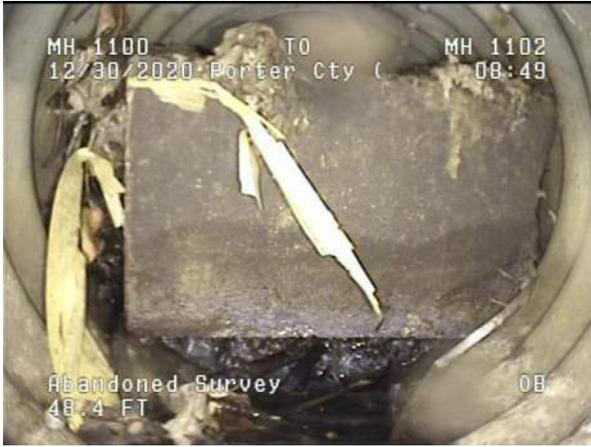
Picture 1 - Pipe 1100-1102: Debris

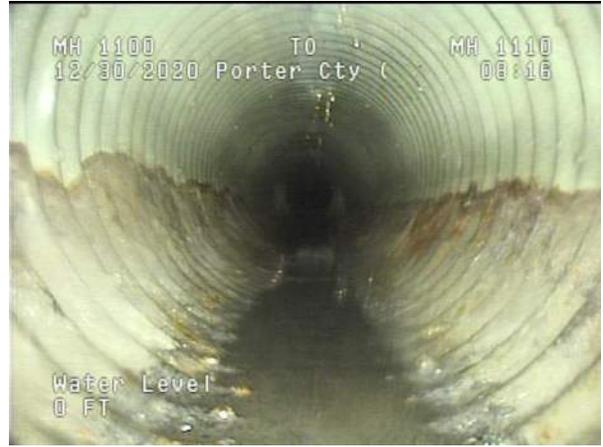
Picture 2 - Pipe 1100-1110: Bottom Corrosion

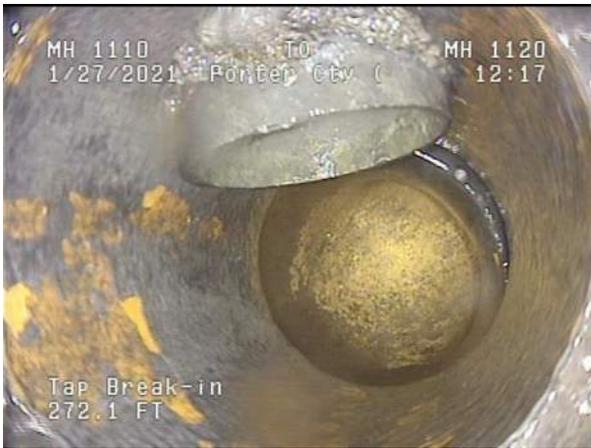
Picture 3 - Pipe 1110-1120: Blind Tap

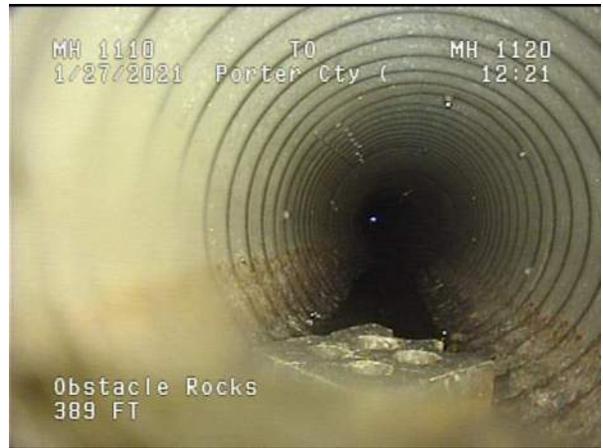
Picture 4 - Pipe 1110-1120: Landscape Block

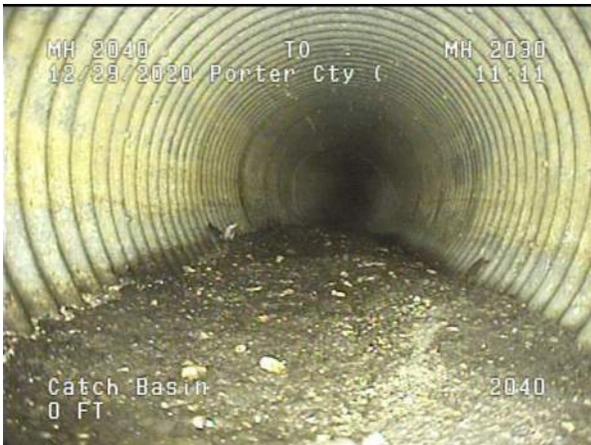
Picture 5 - Pipe 2040-2030: Deposits

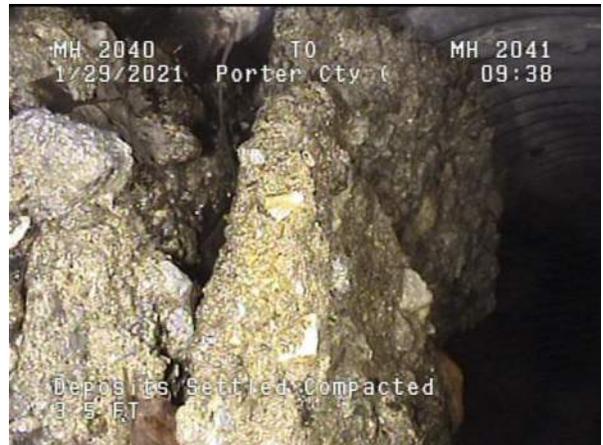
Picture 6 - Pipe 2040-2041: Hardened Deposits

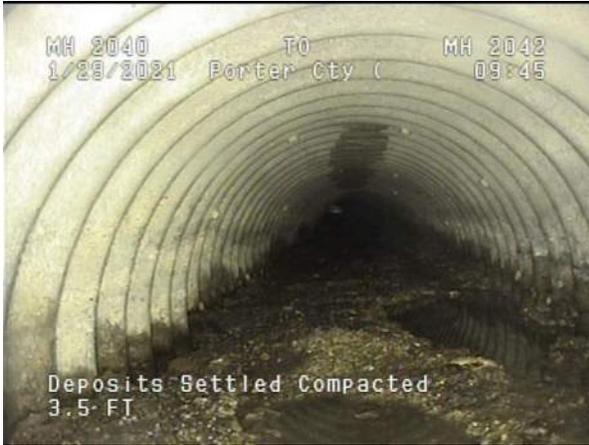
Picture 7 - Pipe 2040-2042: Deposits

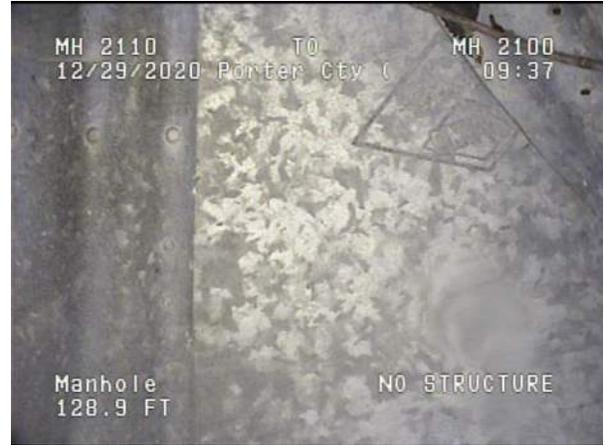
Picture 8 - Pipe 2110-2100: No Structure at Transition

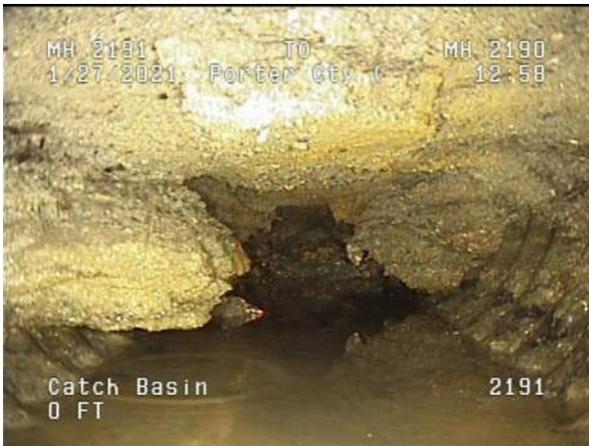
Picture 9 - Pipe 2191-2190: Deposits

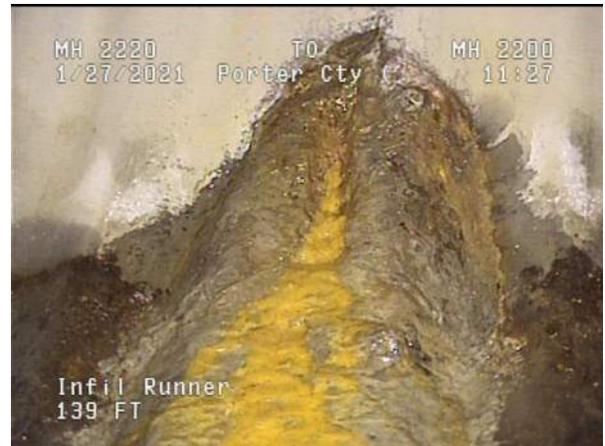
Picture 10 - Pipe 2220-2200: Infiltration Deposits

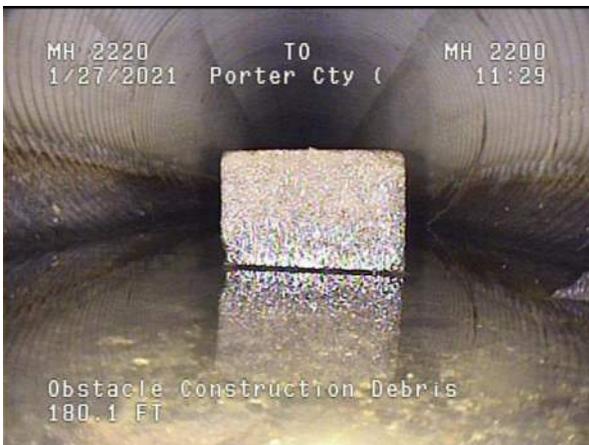
Picture 11 - Pipe 2220-2200: Concrete Block

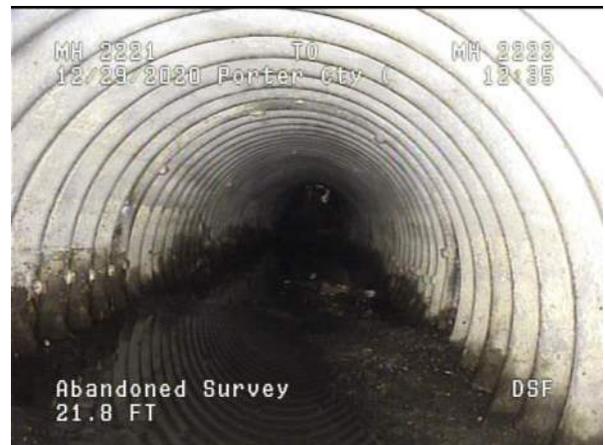
Picture 12 - Pipe 2221-2222: Deposits too Deep For Camera

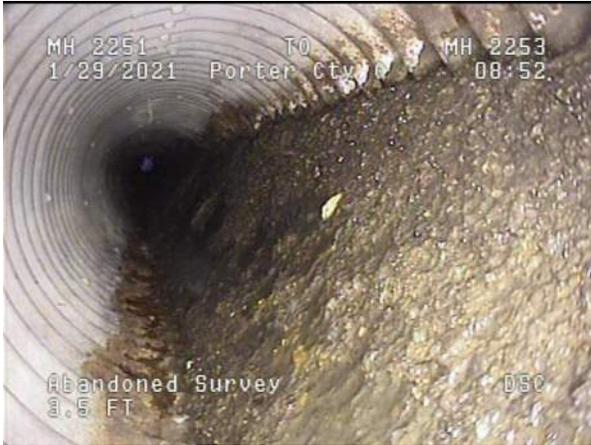
Picture 13 - Pipe 2251-2253: Deposits

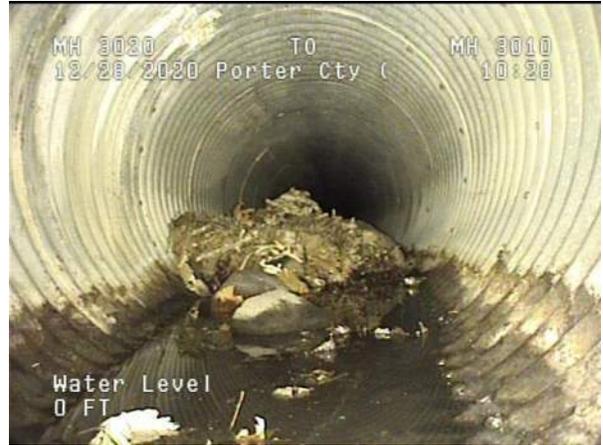
Picture 14 - Pipe 3020-3010: Large Rocks, Video Abandoned

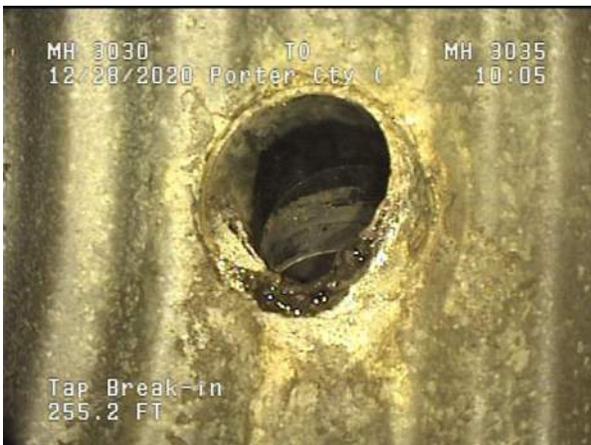
Picture 15 - Pipe 3030-3035: Blind Tap

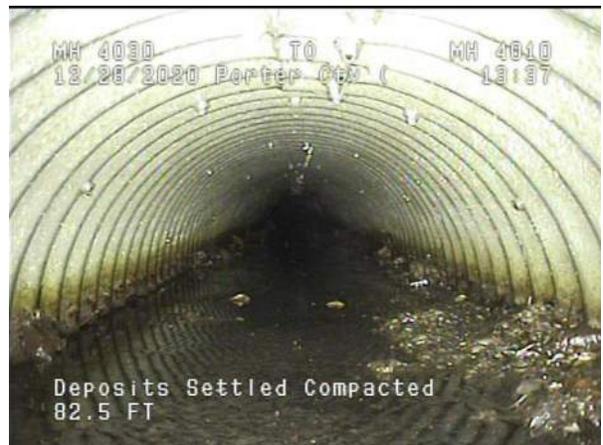
Picture 16 - Pipe 4030-4010: Deep Deposits

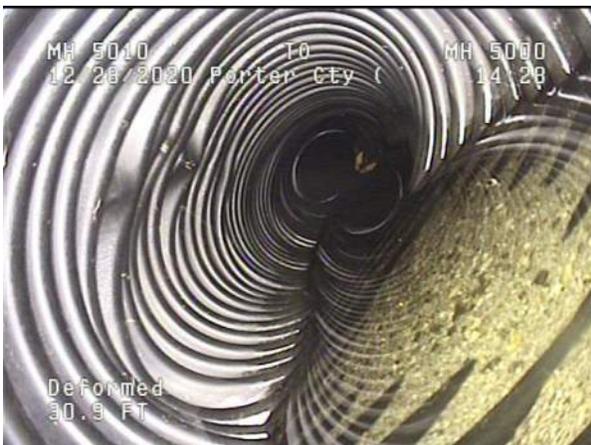
Picture 17 - Pipe 5010-5000: Deformed and Fractured
