Greater South Haven Drainage Study-
Coventry, New South Haven and Salt Creek Valley Commons
Porter County, Indiana

APPENDIX V B - Select Video Inspection Photographs

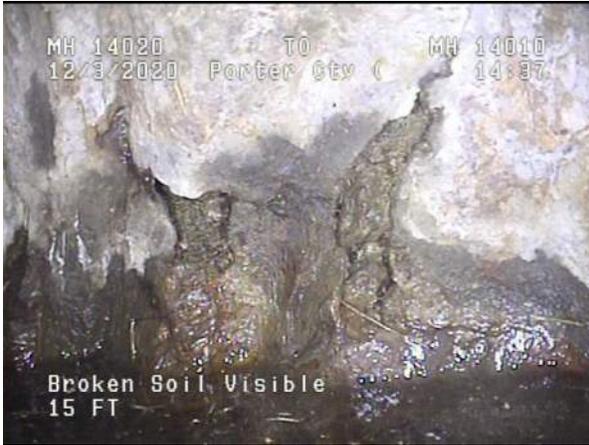
Picture 1 - Pipe 14020-14010: Corrosion, Visible Soil

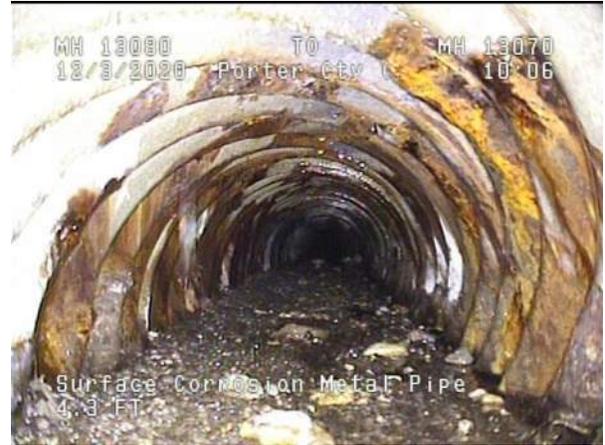
Picture 2 - Pipe 13080-13070: Deposits, Corrosion

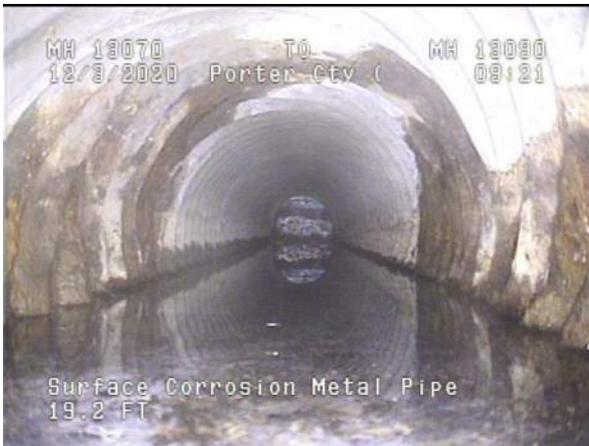
Picture 3 - Pipe 13070-13090: Standing Water, Deposits

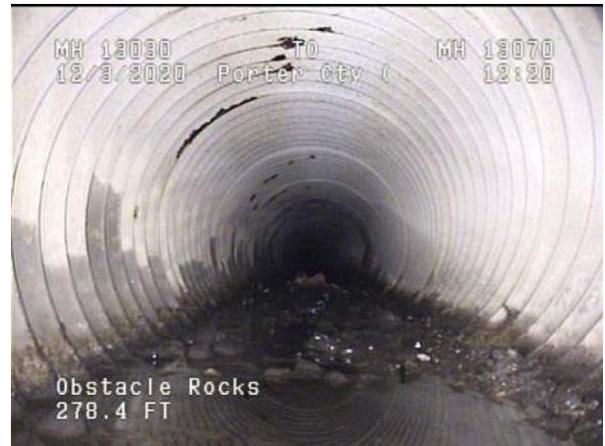
Picture 4 - Pipe 13030-13070: Deposits

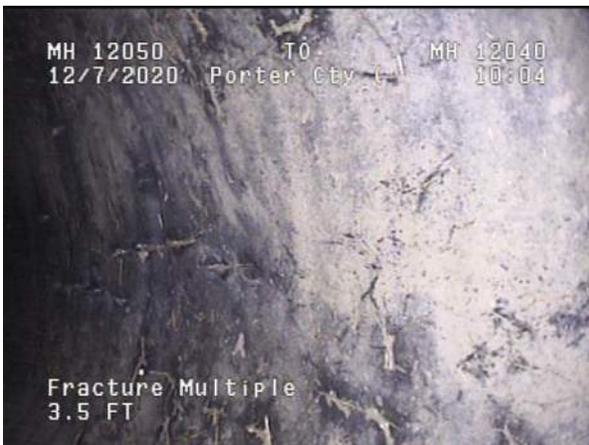
Picture 5 - Pipe 12050-12040: Pipe Fractures

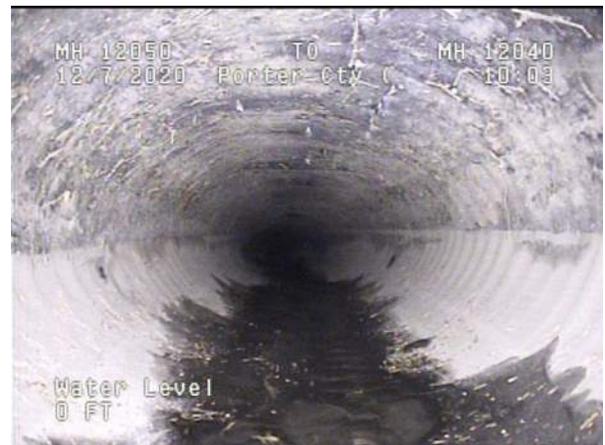
Picture 6 - Pipe 12050-12040: Deformed

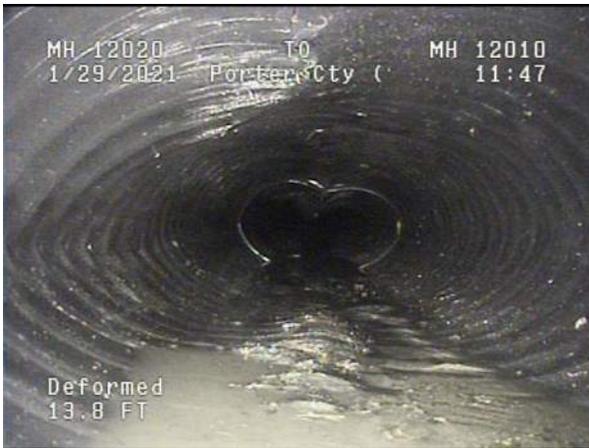
Picture 7 - Pipe 12020-12010: Deformed, Fractured

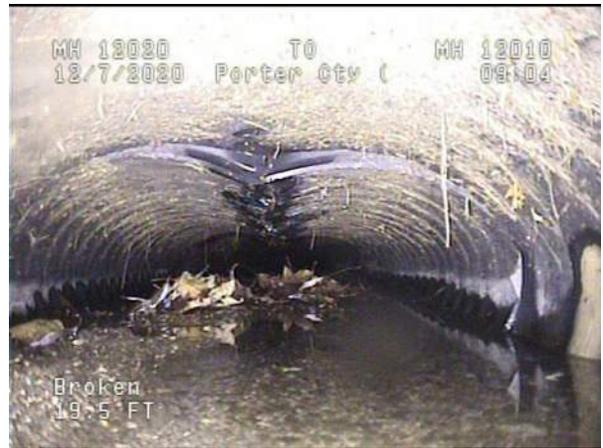
Picture 8 - Pipe 12020-12010: Deformed, Fractured

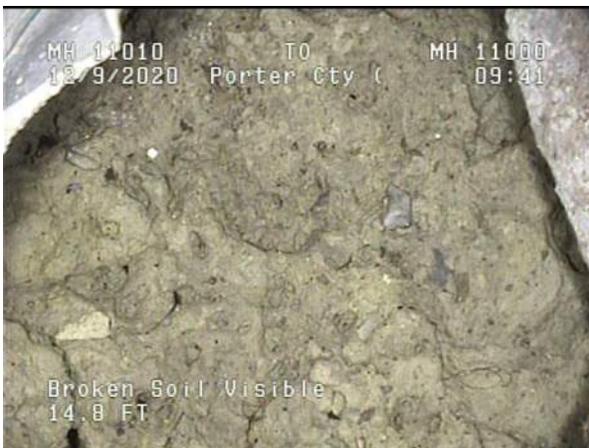
Picture 9 - Pipe 11010-11000: Bottom Missing

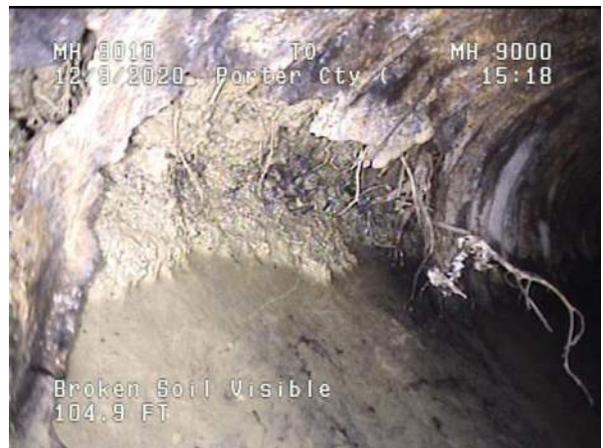
Picture 10 - Pipe 9010-9000: Corrosion, Missing Bottom

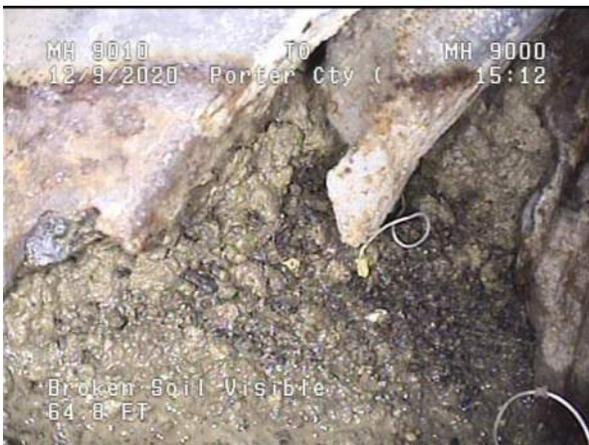
Picture 11 - Pipe 9010-9000: Missing Bottom

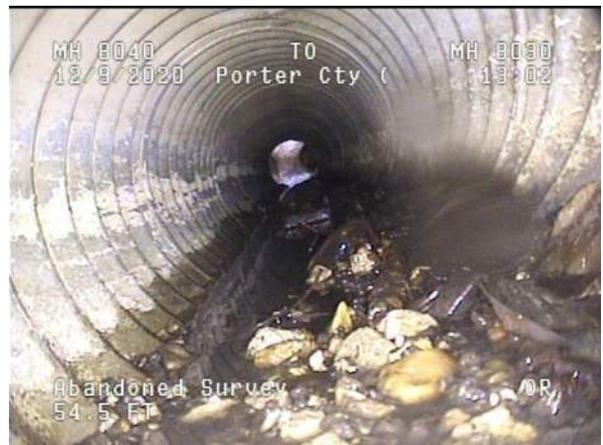
Picture 12 - Pipe 8040-8030: Rocks

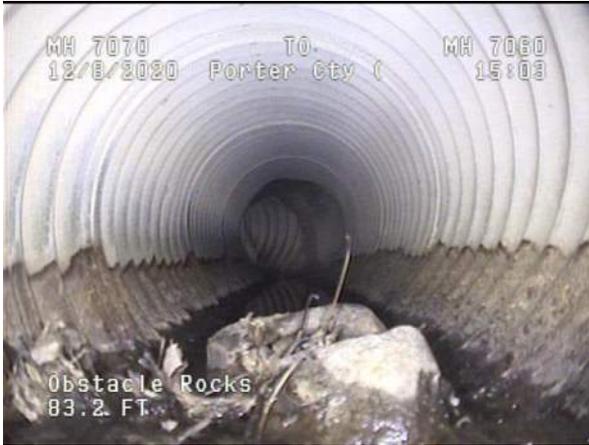
Picture 13 - Pipe 7070-7060: Rocks

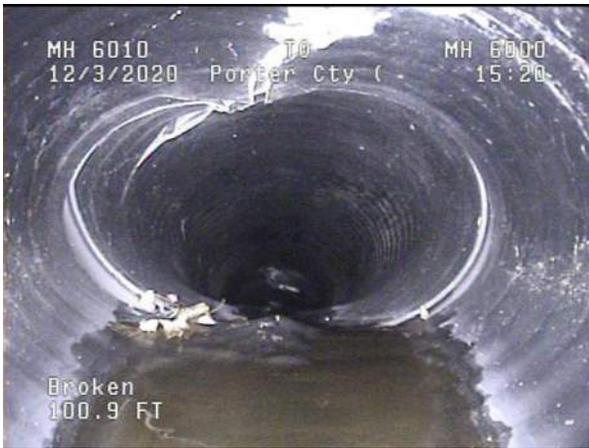
Picture 15 - Pipe 6010-6000: Deformed, Fractured

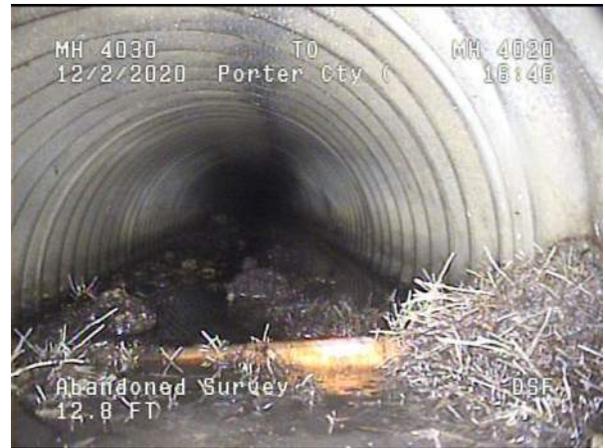
Picture 16 - Pipe 4030-4020: Deep Debris, Roots

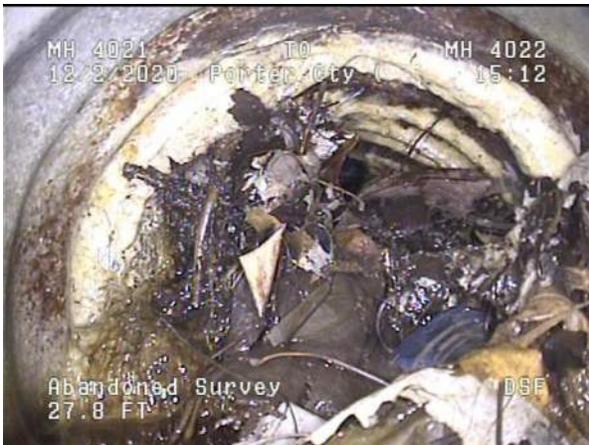
Picture 17 - Pipe 4021-4022: Debris Blockage

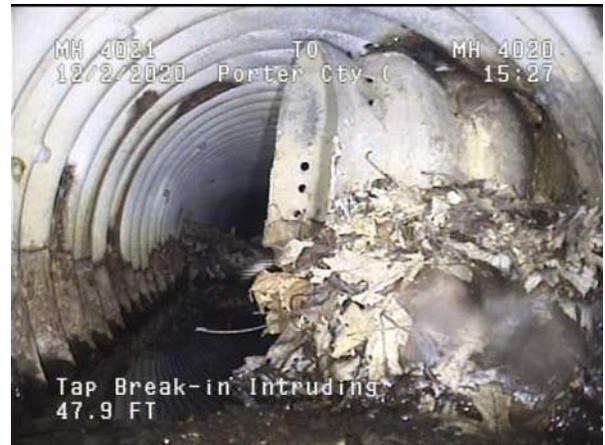
Picture 18 - Pipe 4021-4020: Blind Tap

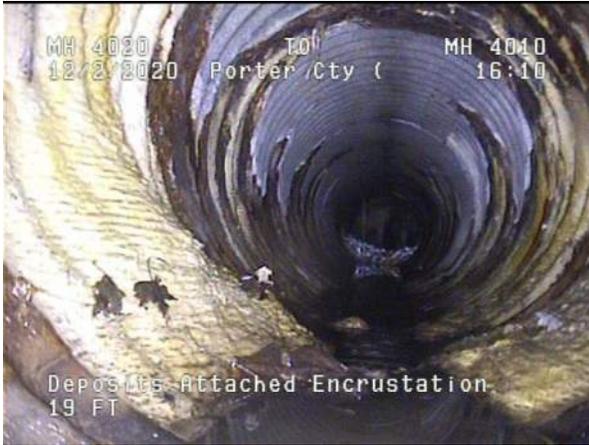
Picture 19 - Pipe 4020-4010: Infiltration Deposits

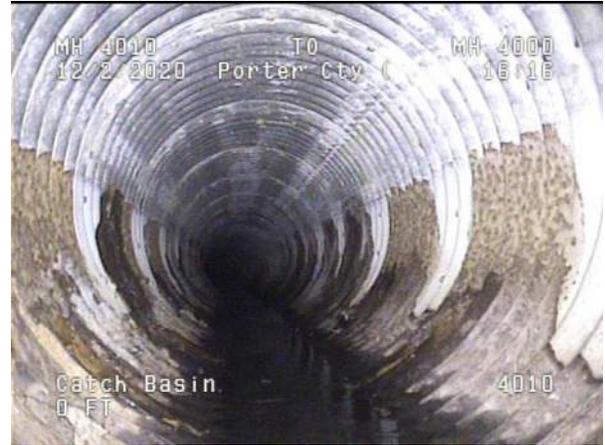
Picture 20 - Pipe 4010-4000: Bottom Corrosion

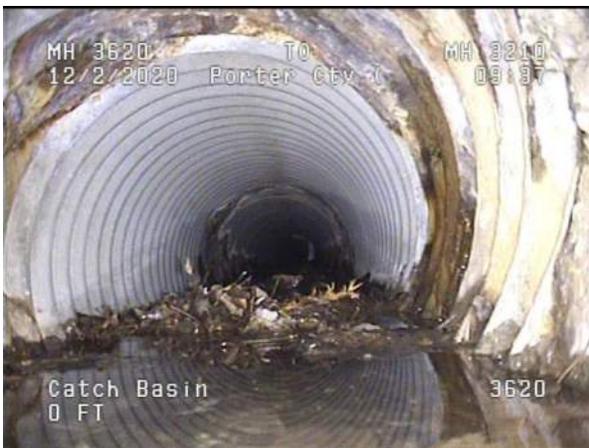
Picture 21 - Pipe 3620-3210: Corrosion, Debris

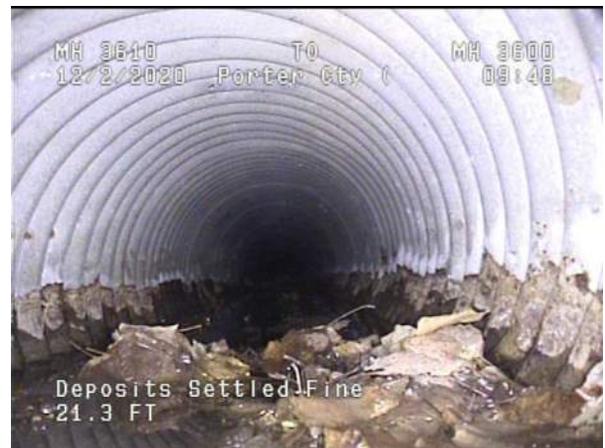
Picture 22 - Pipe 3610-3600: Bottom Corrosion, Debris

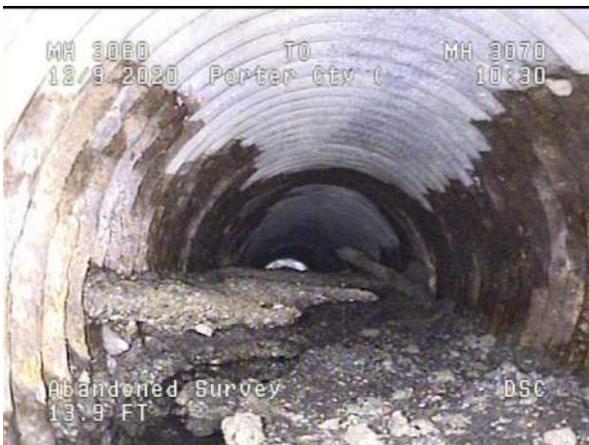
Picture 23 - Pipe 3060-3070: Corrosion, Hardened Deposits

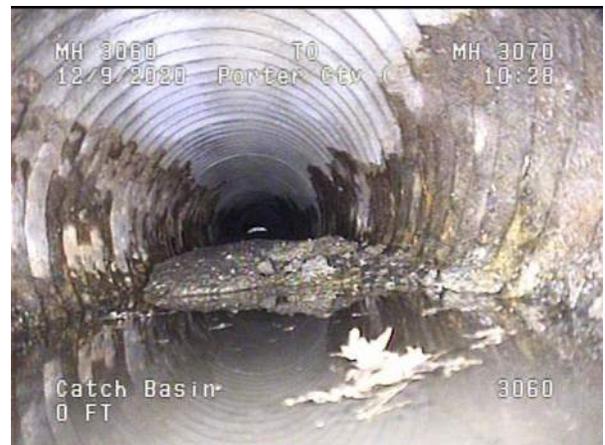
Picture 24 - Pipe 3060-3070: Corrosion, Hardened Deposits

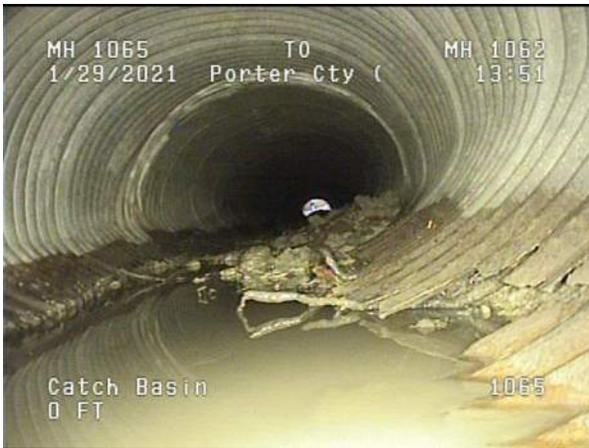
Picture 25 - Pipe 1065-1062: Bottom Corroded,
Exposed Soil
