# Shorewood Forest Subdivision Storm Water Infrastructure Study

January 2023

Porter County Department of Development  
& Storm Water Management

Christopher B. Burke Engineering

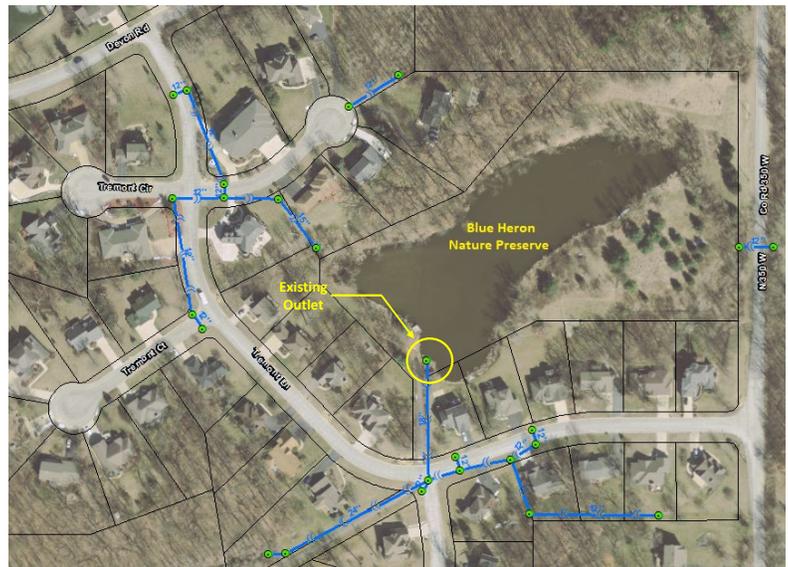
**Figure 5. Blue Heron Nature Preserve**

Under existing conditions, this wetland outlets through an 18-inch RCP storm sewer located at the southwest corner of the site, and ultimately drains to the Devon Ravine through a 24-inch diameter storm sewer adjacent to the Nature Walk, as shown in **Figure 12**.

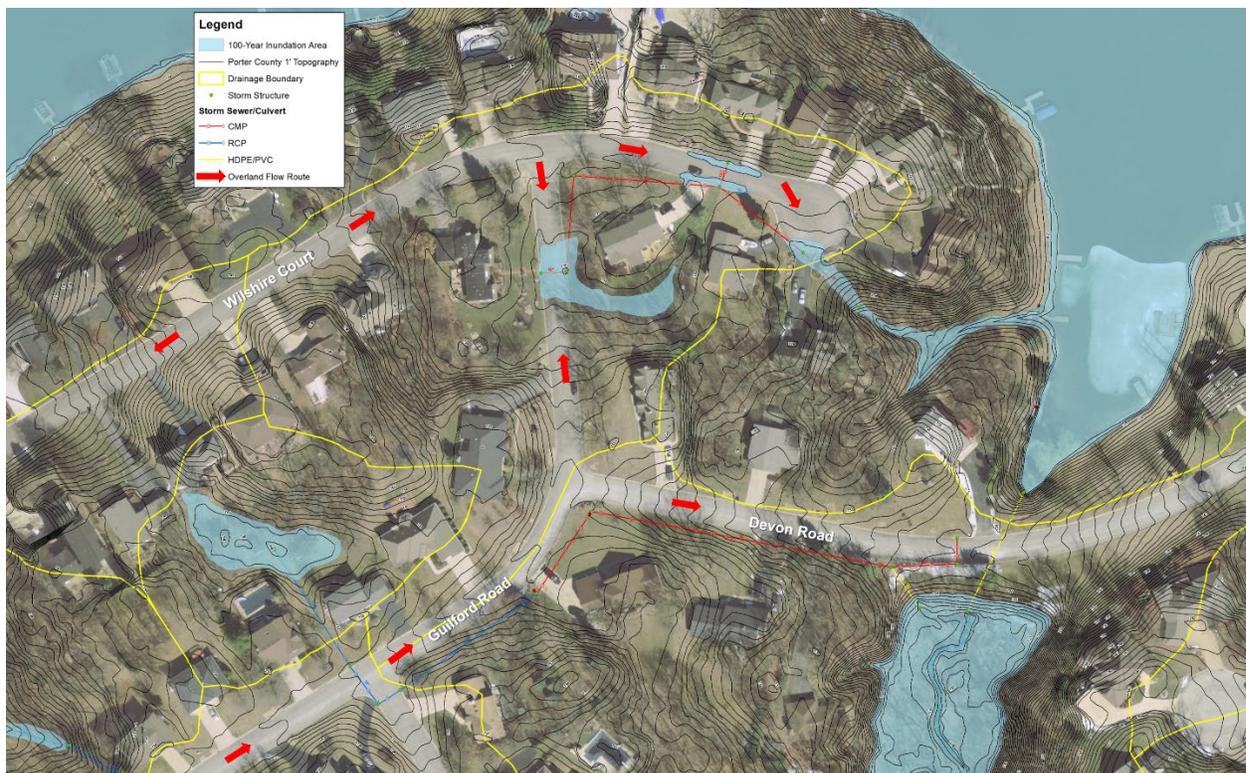
Figure 6. Existing Conditions Drainage - Problem Area 6

The existing drainage system consists of 12- to 15-inch CMP storm sewers that outlet to a channel located between 368 and 370 Wilshire Court. The overland drainage pattern along Wilshire Court is from west to east, while the drainage pattern is generally south to north along Guilford Circle. This system includes approximately 5 acres of drainage area, but additional runoff from Guilford Circle (south of Devon Road) may occur during intense storm events

There is a “bowl” located along Guilford Circle that connects to additional low-lying area within the rear/side yard of 374 Wilshire Court. When the capacity of the storm sewer system is exceeded, stormwater ponding occurs in the street and in the side/rear yard of this residence. Additional, during intense storm events, the existing inlets on Wilshire Court become overwhelmed and stormwater runoff is funneled toward the cul-de-sac. The capacity of the existing inlet located within the driveway of 370 Wilshire Court will be exceeded, resulting in stormwater ponding at the end of the cul-de-sac that eventually will overtop the driveway and flow overland between the homes. Based on the XP-SWMM existing conditions analysis, stormwater ponding will occur in this location for 25-year magnitude storm events or greater.

Based on the results of the pipe condition assessment, this existing storm sewer network is in moderate to poor condition.
