PIPE ASSESSMENT SUPPORTING DOCUMENTATION

Shorewood Forest Subdivision Stormwater Infrastructure Study
Storm Sewer Televising Summary

**SHOREWOOD FOREST
STORM SEWER
SECTION 3**

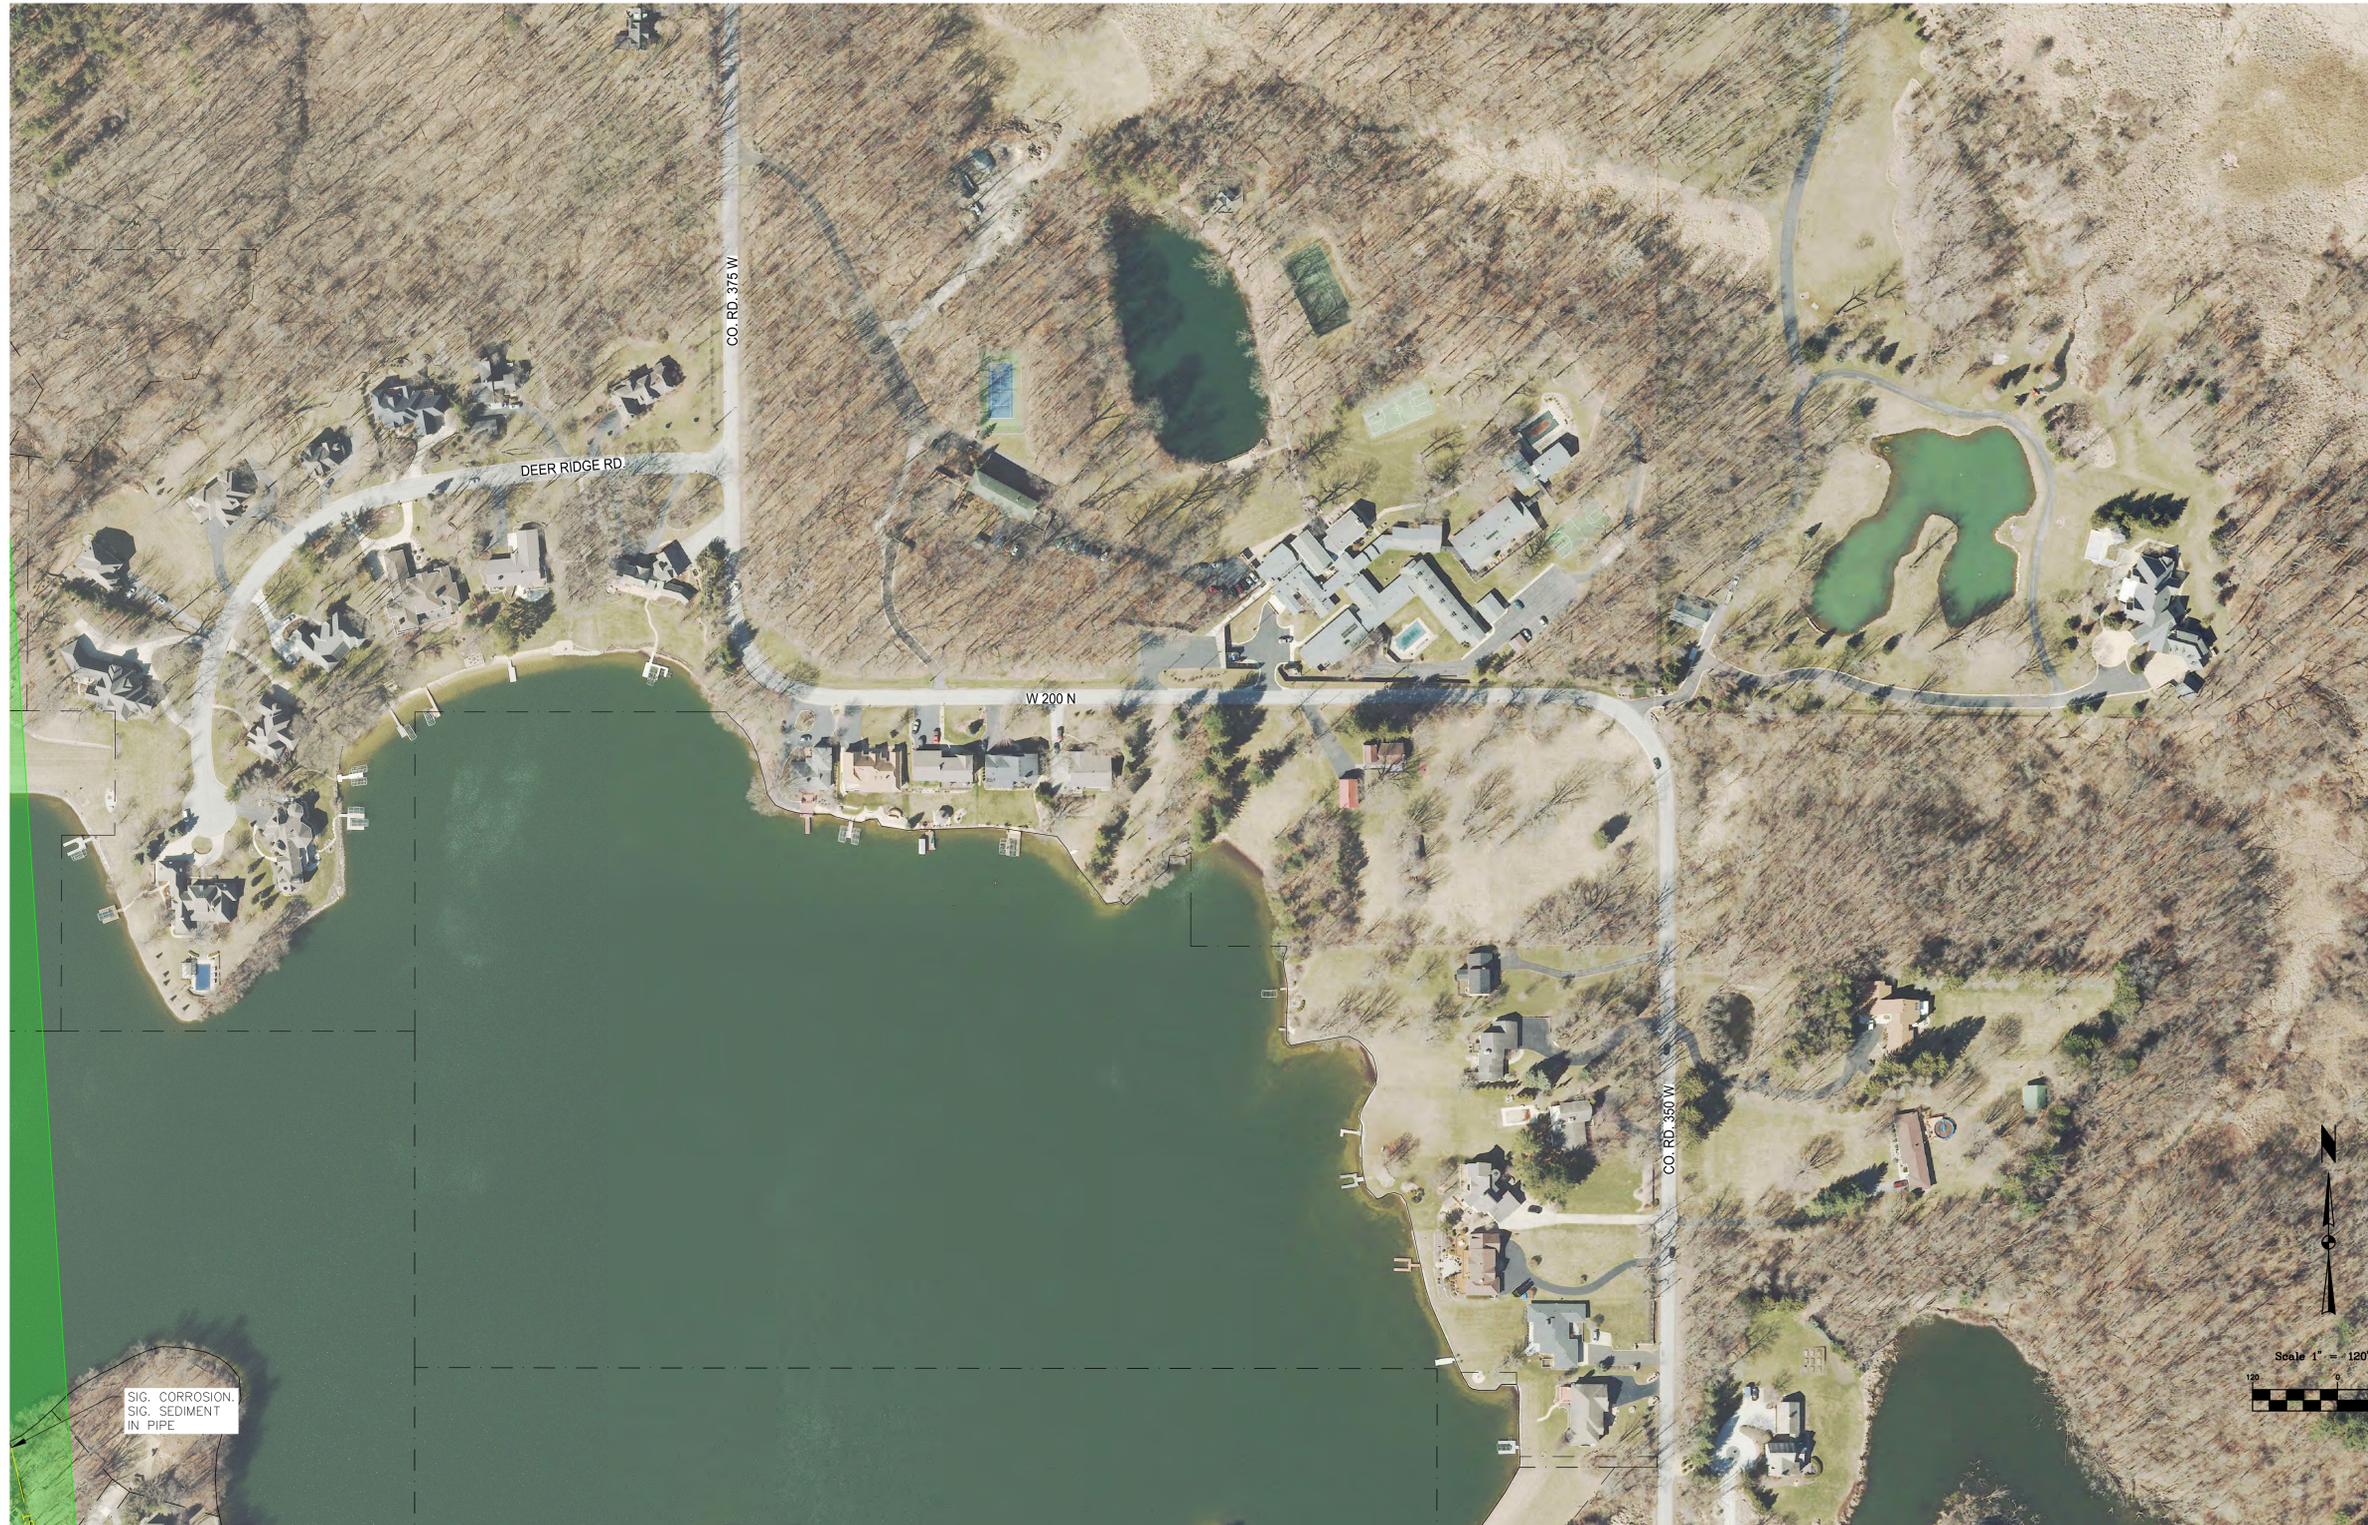
PROJ. NO. 20-0085.00000
DATE: 1/15/2021
SHEET 6 OF 10
DRAWING NO.
6

**SHOREWOOD FOREST
STORM SEWER
SECTION 6**

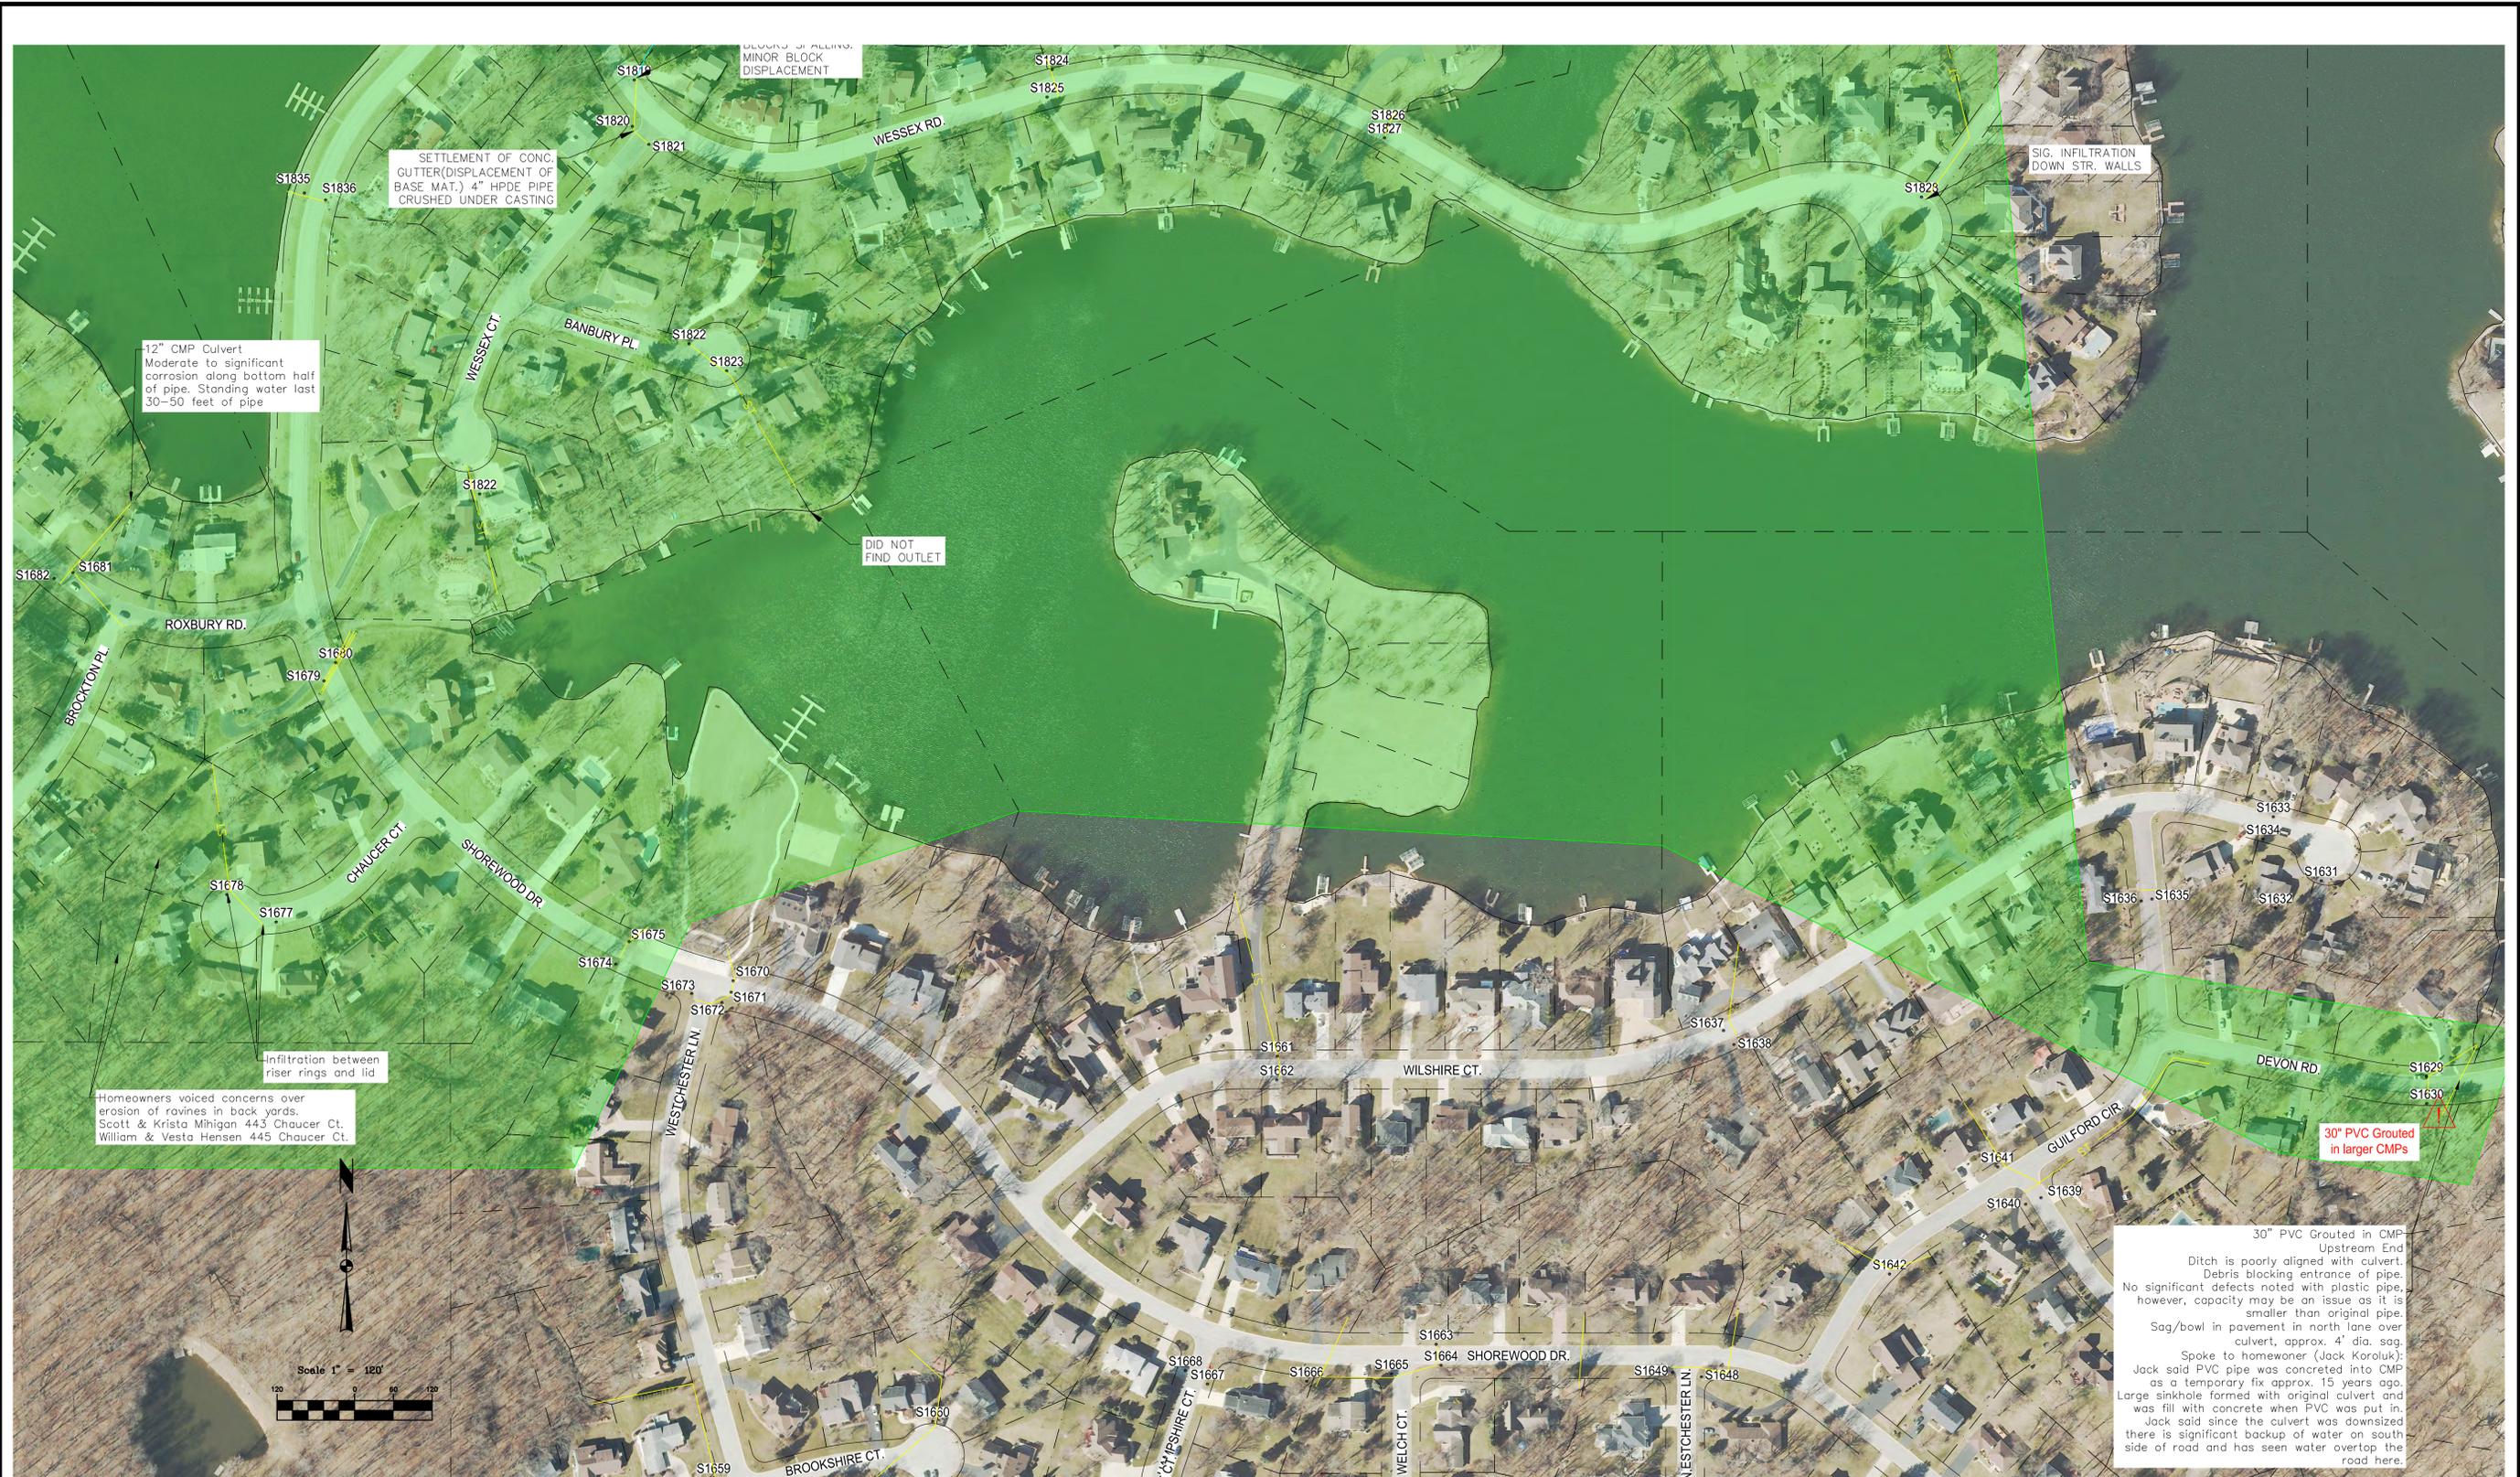
PROJ. NO. 20-0085.00000
DATE: 1/15/2021
SHEET 8 OF 10
DRAWING NO.
8

**SHOREWOOD FOREST
STORM SEWER
SECTION 8**

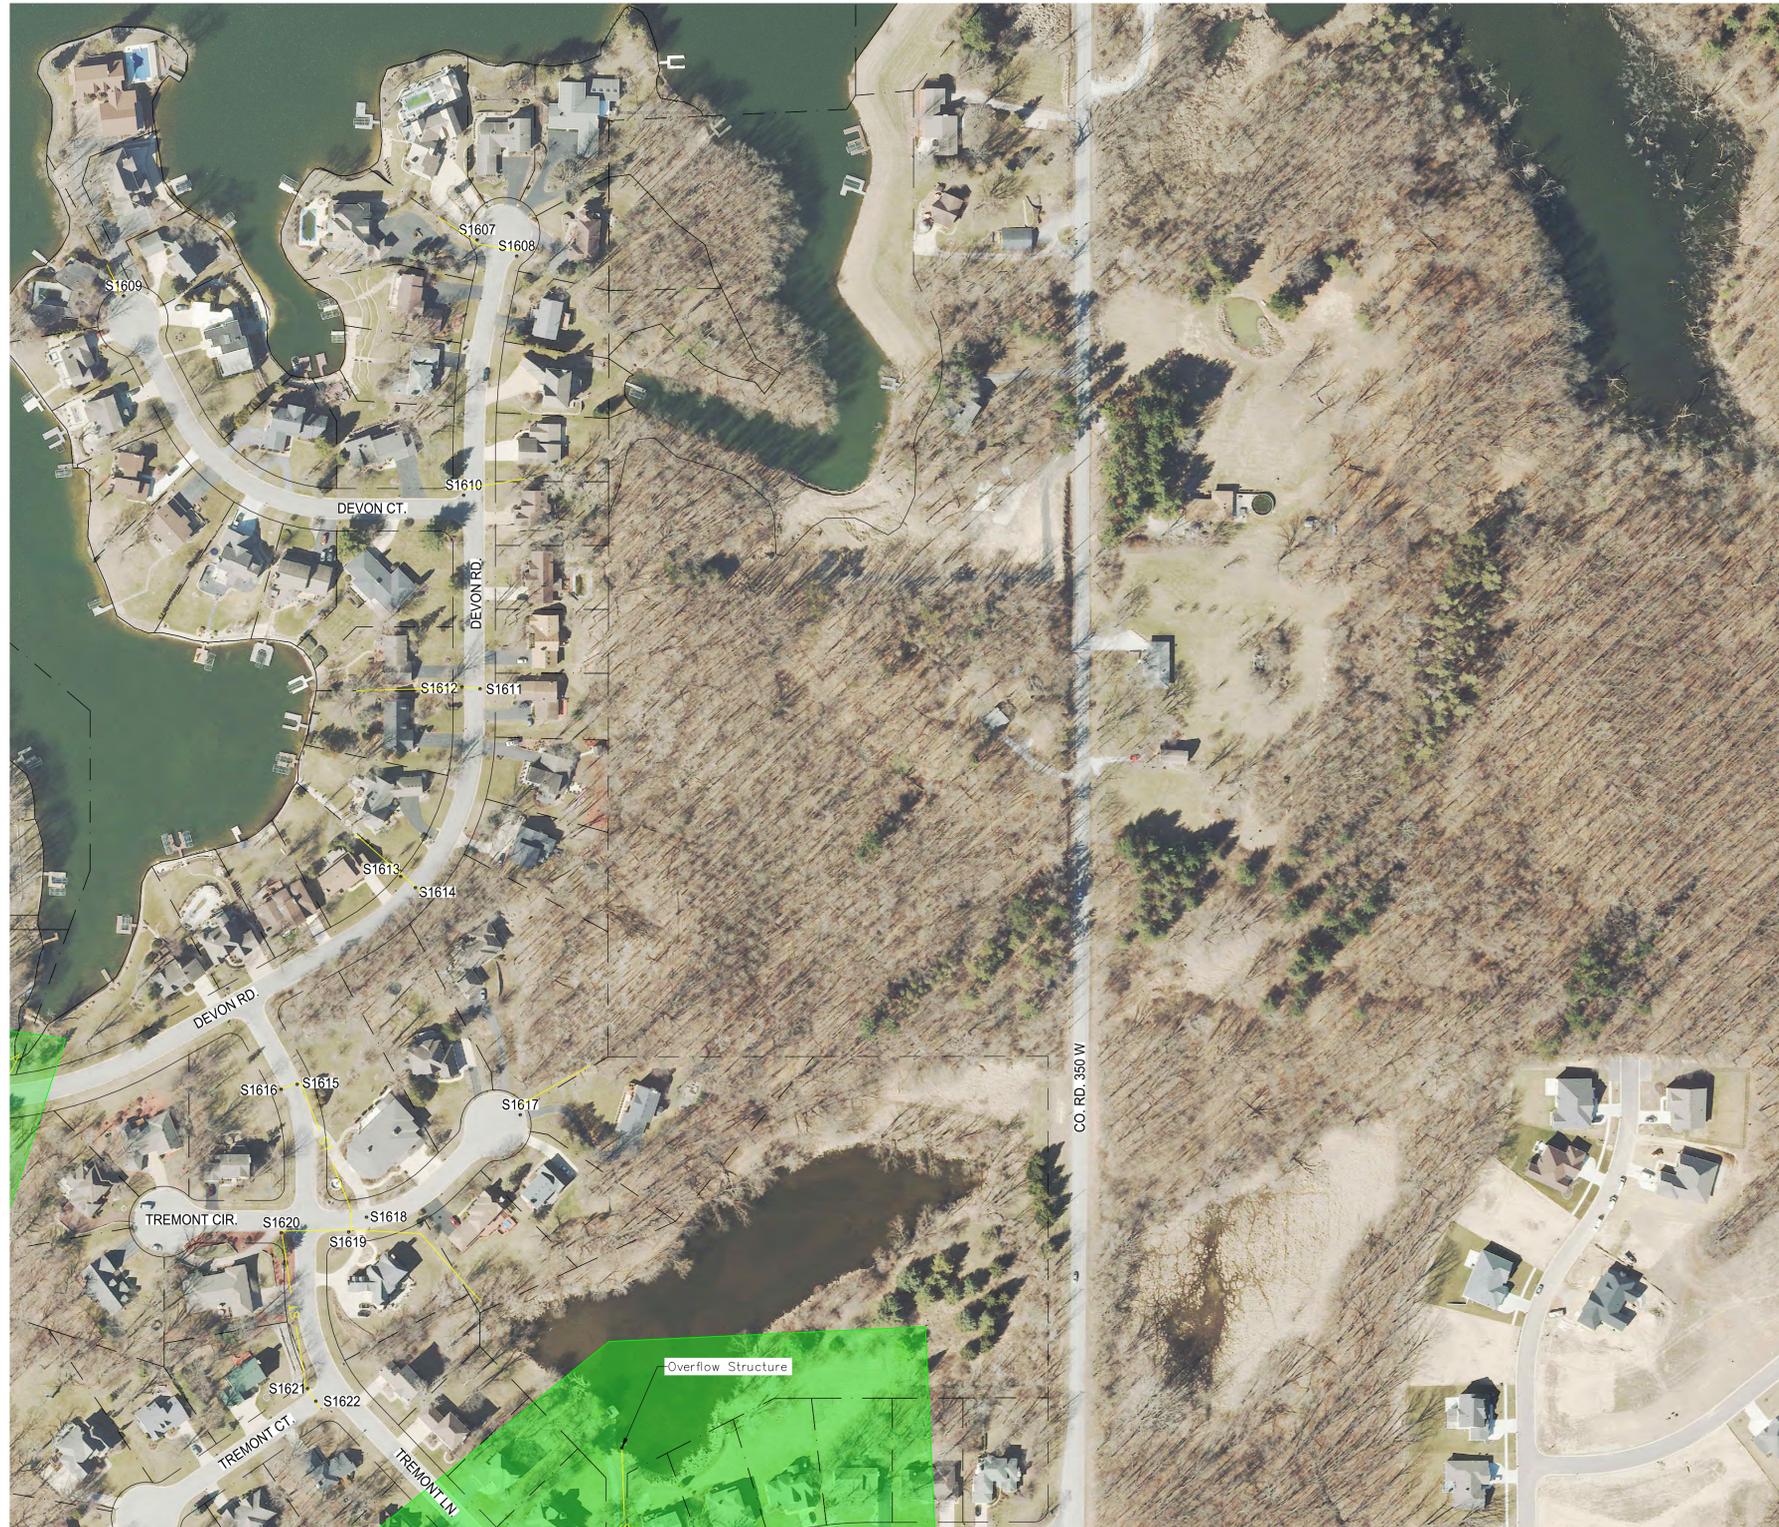
PROJ. NO. 20-0085.00000
DATE: 1/15/2021
SHEET 9 OF 10
DRAWING NO.
9

**SHOREWOOD FOREST
STORM SEWER
SECTION 9**
